# Overflow Pattern and the Formation of Scoured Region by the Tsunami Propagated in River Channels in Great East Japan Earthquake

N. Tanaka<sup>1, 2</sup>, J. Yagisawa<sup>1, 2</sup> and S. Yasuda<sup>2</sup>

**Abstract:** *The tsunami caused by the Great East Japan Earthquake on 11 March 2011, with a magnitude of 9.0, caused catastrophic damage to people and buildings in the Tohoku and Kanto regions of Japan. A field survey was conducted to elucidate the damage to river embankments and their hinterlands (residential area) by tsunami propagation in river channels and overtopping of embankments. Three, three, and four rivers in Iwate Pref., Miyagi Pref., and the Kanto Region, respectively, were selected for the field investigation. In the hinterlands, the tsunami came from coast and river, and the situation, including the evacuation of people, became complex. Tsunami inundation patterns were classified by the river capacity and whether a river or sea embankment was breached or not. This will provide useful information for making new hazard maps and planning new cities.*

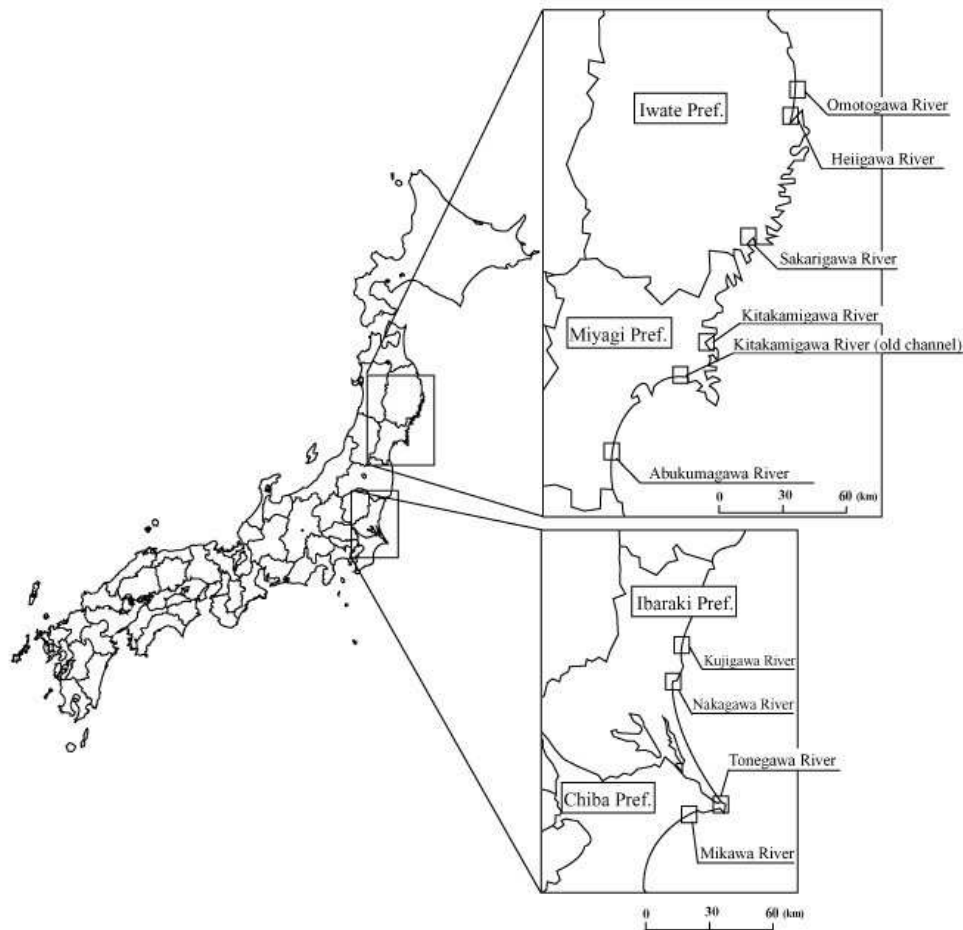
**Figure 2 Location of investigation sites (locations of the mouth of each investigated river are shown in this figure)**

in April and May 2011. Figure 1 shows the location of the mouth of each river.

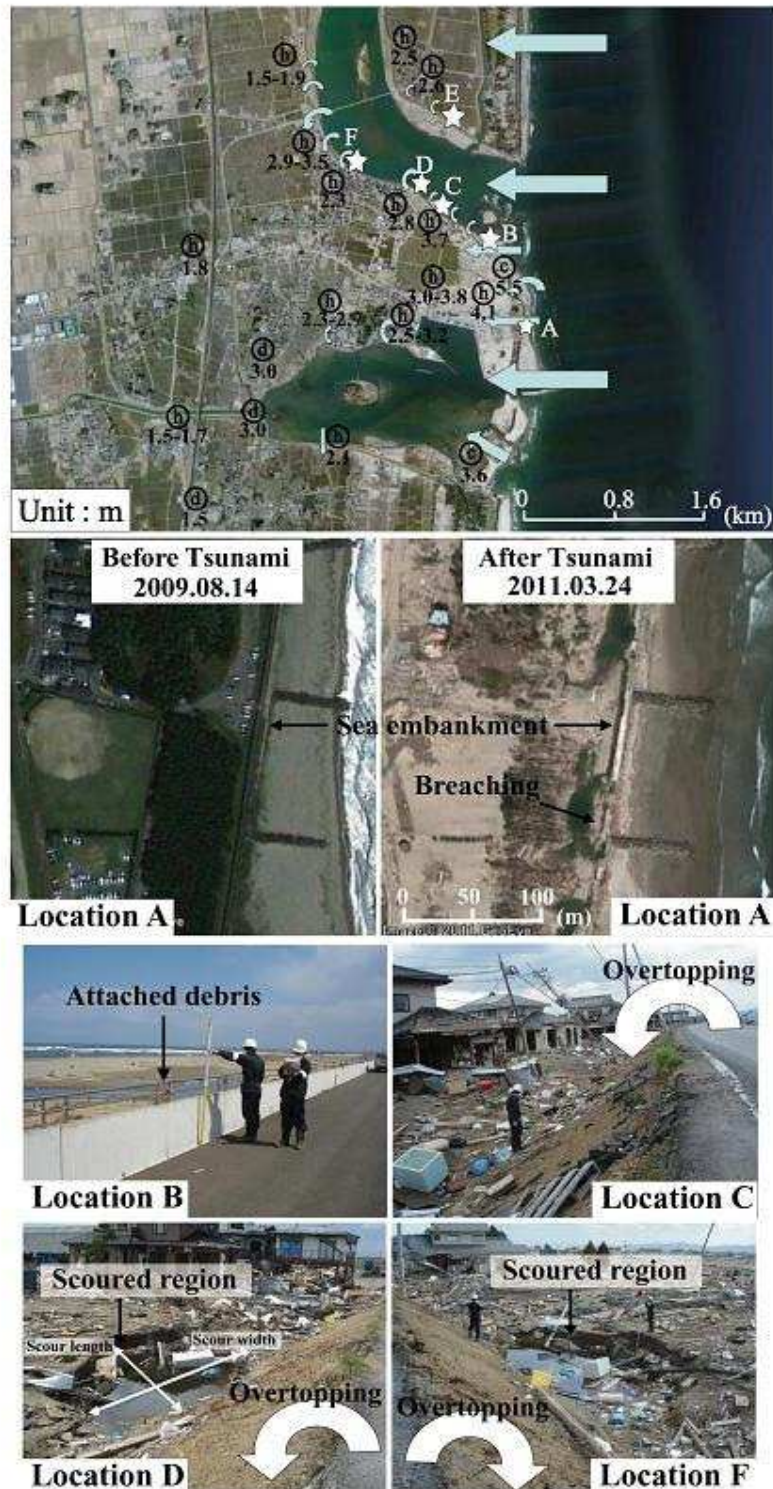
Figure 2 Damaged situation in Abukumagawa River Basin

The direction and water depths of the tsunami inundation around the Abukumagawa River are shown in Figure 2. At location A, breaching of the sea embankment was observed. Behind the sea embankment, large areas were scoured by the tsunami overtopping of sea embankment. Near this region, the tsunami water depth was around 5.5 m and the embankment height was 4.8 m. At location B, the overtopping water depth at the top of embankment was estimated to be around 1 m based on the debris attached to the fence on the embankment. Just downstream, the river embankment was also breached by direct attack of the tsunami. The overtopping from the river to the hinterland was severe at location C, but was a little less severe upstream at locations D and E. However, the overtopping became severe again at location F because it was located on the outer-bank side of the river. The extent of overflow was judged from the erosion of the river embankment slope and scoured regions around houses and the broken or washed-out condition of houses. The elevation of the road along the river was higher around location F than in locations D and E, so the difference between the ground level of houses and the road was greater. In location D and E, the road in front of houses had a role to prevent erosion, however location D, downward flow still continued and caused erosion. In that case, the overtopping flow caused scoring and local scour around houses that combined to generate large scour area (Figure 3). Thus, houses around location F were completely washed out, not by the tsunami propagated from seaward, but by the tsunami overtopping the river. Similar overtopping from outer bank of a river was also observed in old Kitakamigawa River.

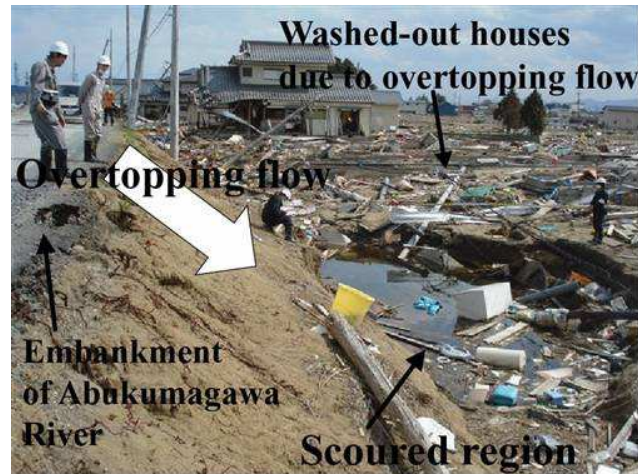
Figure 3 Large scoured region by overtopping flow (Right hand side of Abukumagawa River)

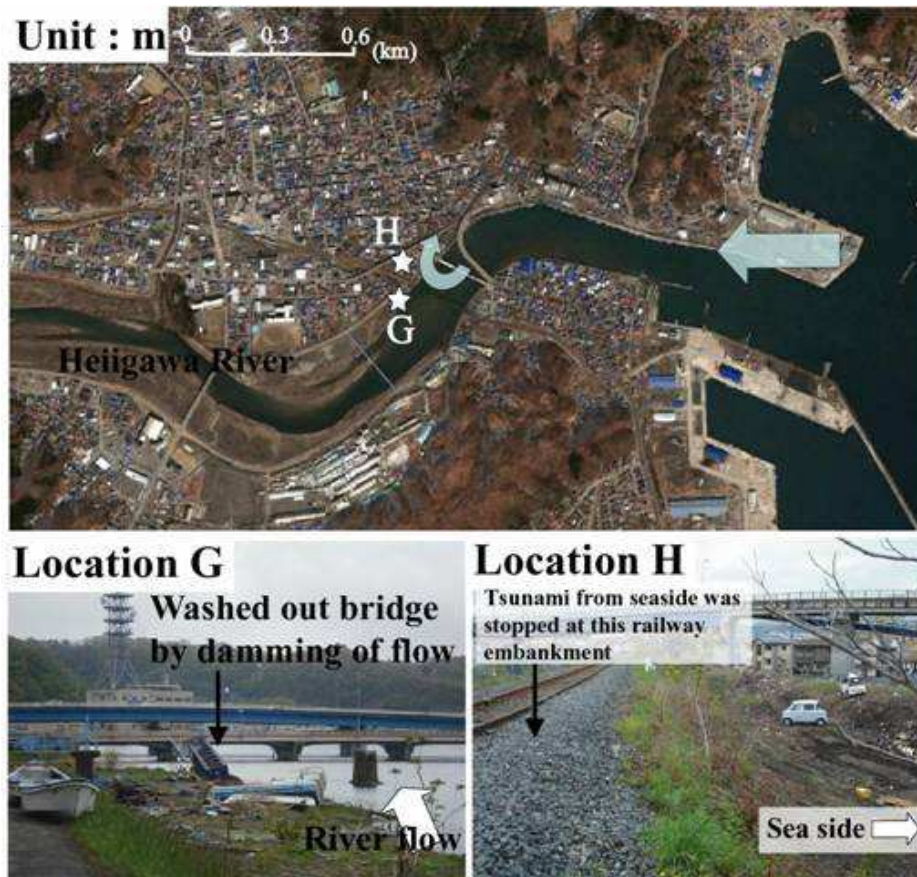
Figure 4 Damaged situation in Heigawa River Basin

In case of Heigawa River (Figure 4), a railway bridge which is 1.5 km upstream from the river mouth was washed out after the damming of flow by debris including a ship (Location G). People who temporally escaped on the railway embankment needed to escape far inland by the destruction of the bridge and railway. Most of the tsunami from seaside was stopped at the railway embankment (Location H), but tsunami also propagated by sewage pipe line, inundated in the inland region of the embankment, and overflowed from the upstream river embankment when the railway bridge was broken. This case shows that; 1) bridge has some possibility to be a trigger of the overflow from embankment, and 2) tsunami also propagated from sewage line. This should be considered for the tsunami simulation and hazard mapping.

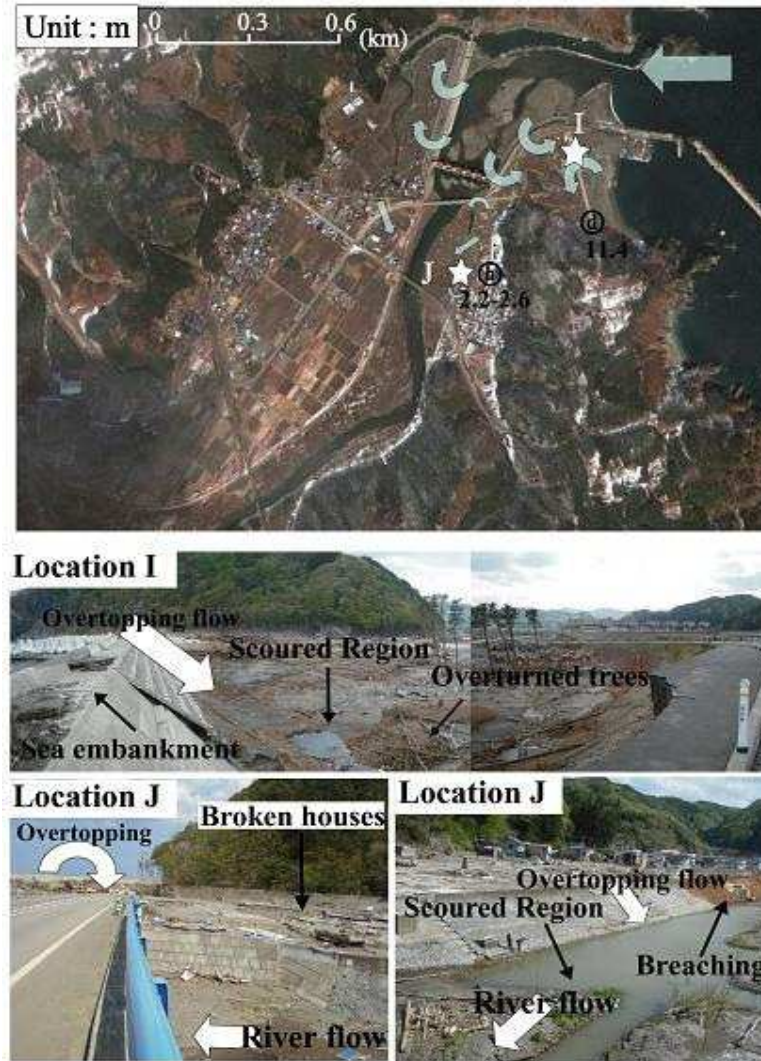
Figure 5 Damaged situation in Omotogawa River Basin

The Omotogawa River (Figure 5) has a tsunami gate and high sea embankment (around 10 m from the ground on the hinterland side). The overtopping tsunami depth from sea embankment was assumed to around 1.6 m. Many large concrete blocks in front of the sea embankment had been transported by the tsunami, a large scoured region had been generated behind the sea embankment, and the pine trees near the region were overturned (Location I). Most of the houses near the sea and river embankment were washed out by the

overtopping flow (Location J). From large scoured regions on floodplain of the river bed, and a scattered region of a broken parapet on the embankment, the breaching was supposed to be occurred from the inland side to the river. Even if a tsunami gate had existed, the tsunami would have been higher than the tsunami gate and the sea embankment; in fact, the tsunami inundation occurred mainly from the high embankment with high potential energy, and washed out or broke the houses. On contrary, in case of a small river in Chiba prefecture, the tsunami was stopped at the gate, because the tsunami height was low in comparison with Iwate Prefecture.

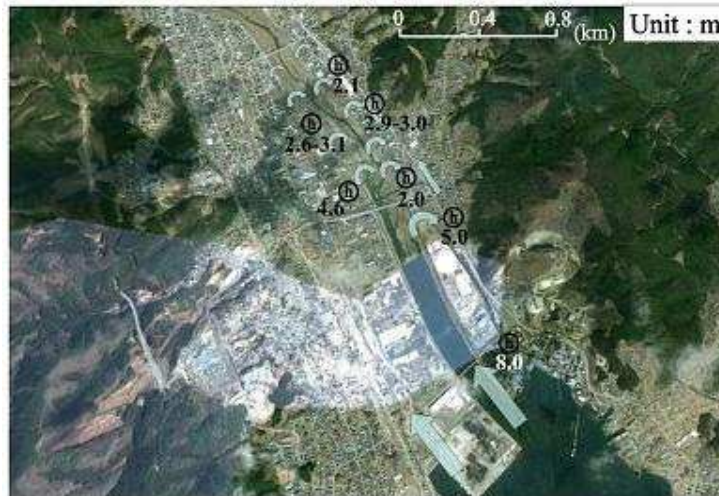
**Figure 6 Damaged situation in Sakarigawa River Basin**

In case of the Sakarigawa River basin (Figure 6), the presence of a road and train embankment changed the direction of most of the tsunami flow intruded from seaward. The tsunami passed through only the culvert of the embankment from seaward to inland, but it continued to overtop the river embankment. Thus, the people who lived upstream of the road and railway embankments received tsunami inundations from two directions. However, in this case, the tsunami overflow from river embankment itself was not large compared with that of the Abukumagawa River. The inland embankment for railway or road is very useful in some cases and needs to be utilized more, considering the tsunami inundation pattern.
