# **Study on the Cracks Developed in Dematamal Viharaya, Uva Province Sri Lanka**

Stupas of Sri Lanka stand as proud examples for the engineering Excellence of ancient Sri Lanka. Dematamal Viharaya at Butthala is one of the oldest Stupas in Sri Lanka built in the 2<sup>nd</sup> Century BC. It is a, 19m tall non-plastered brick structure.

This Stupa has developed since 1998. Cracks have initiated from the Pesawalalu and propagate to the top of the Dome. The width of these cracks varies from 0.2mm to 0.5mm.

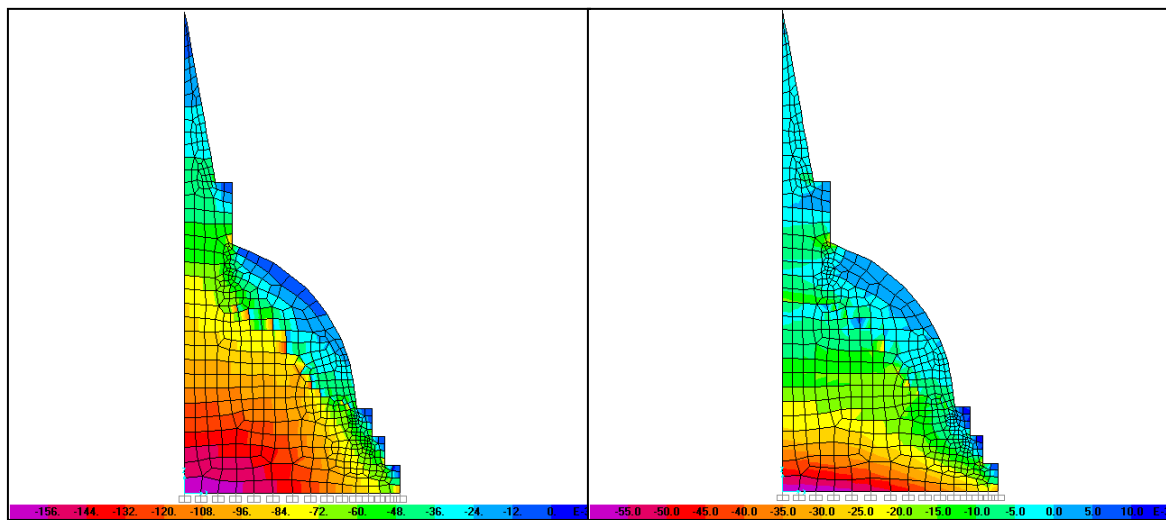
***Figure : Vertical and Hoop Stresses due to Self weight of the Stupa modelled with modern brick properties***

Figure 1 shows the Vertical and Hoop stresses in the Stupa. The Vertical Stresses are wholly compressive in the range of 0.156Nmm<sup>-2</sup> to 0.003Nmm<sup>-2</sup> and steadily increase from top to bottom. Maximum Compressive stresses can be noticed at the base. As for the Hoop stress it is mainly compressive and has a variation similar to the vertical stress, but tensile stresses also can be seen at the outer edge of the dome and in the edge of the *Pesawalalus*, where cracks have appeared in the Stupa. But the tensile stresses are less than 0.01 Nmm<sup>-2</sup> which is approximately one fifth of the

tensile strength of the modern bricks. So it can be concluded that the self weight had not been the reason for the cracks.

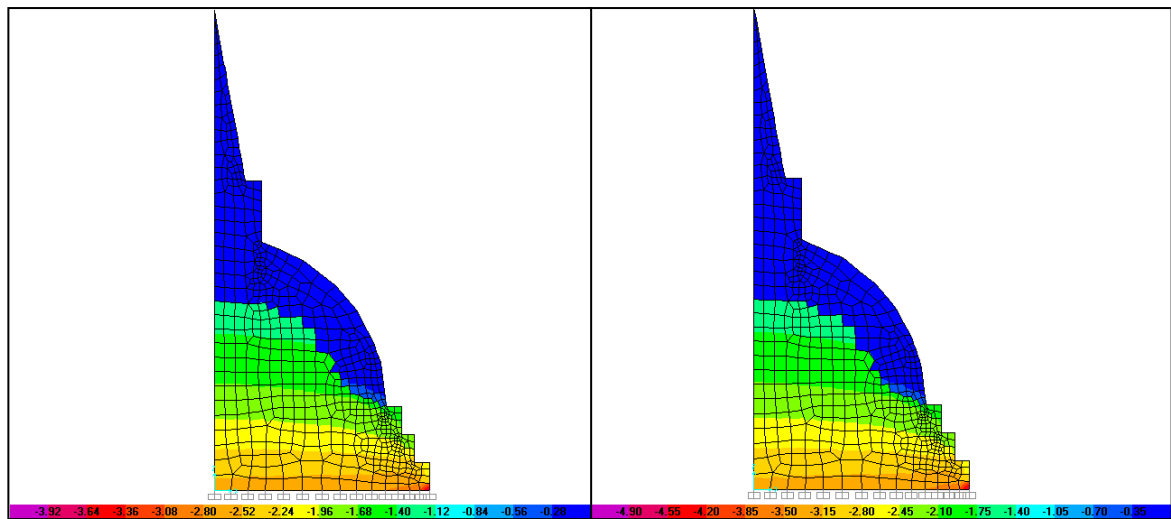
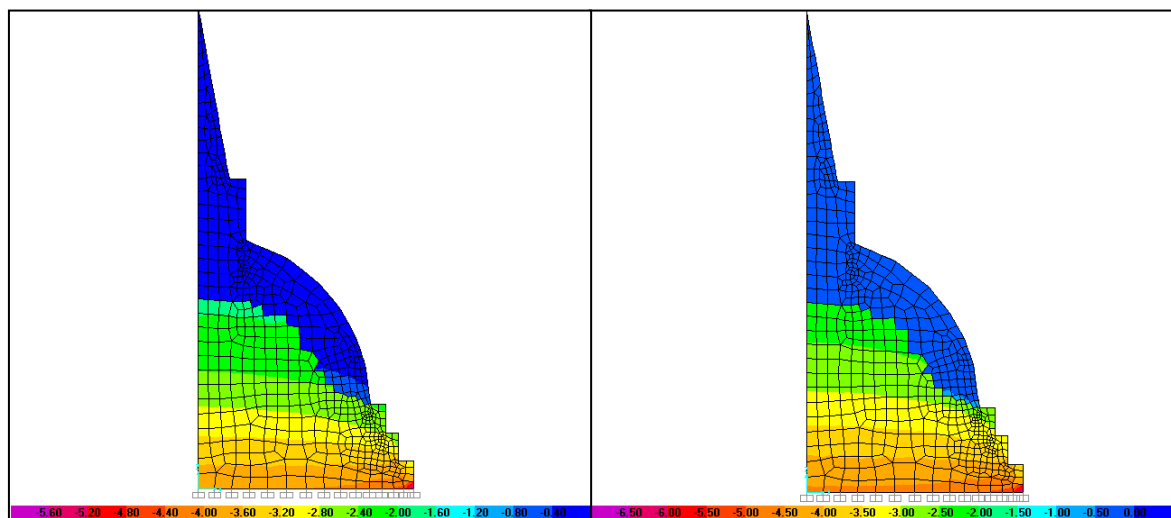
*Figure 3: Hoop Stresses at 20°C and 25°C*

From the above models it can be concluded that the hoop stresses are compressive and they increase while the temperature is increased. But the highest compressive stress obtained is  $6.5 \text{ Nmm}^{-2}$  in the base of the Stupa constructed with ancient bricks. This value does not exceed the strength ( $11.6 \text{ Nmm}^{-2}$ ) of the material.

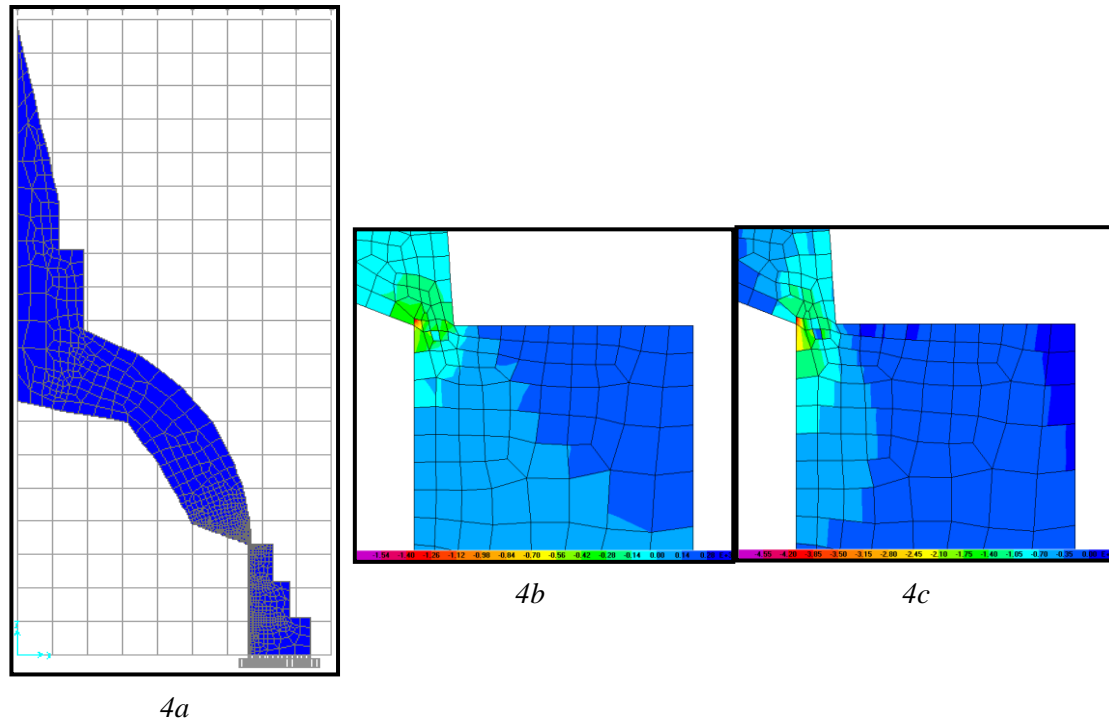
**Figure 4 : (a) Model used to analyse arch action (b) Hoop stresses at the base of the arch (c) Vertical stresses at the base of the arch**

It can be clearly noted that a increase in compressive stress occurs at the base, whether it be Vertical, Radial or Hoop Stress. In the case of Vertical stress the increase compared to the model with both materials is forty times higher where as it is 400 times an 90 times higher in the radial stress and Hoop stress respectively.

It also shows the development of high hoop tensile stresses in the *pesawalalu* edges thus proving the second part of the hypothesis to be true. The general range of the Hoop stress at the pesawalalu is  $0.14\text{-}0.28 \text{ Nmm}^{-2}$ , an increase of 250 times compared to the self weight model.

High compressive stresses develop at the base of the new material. This is because the area of the bearing is very small, thus not able to carry the stresses induced by the arch action. By increasing the bearing this problem could be solved. A tie beam around the pesawalalu will be able to compensate for the hoop tensile stresses developing at the pesawalalu.
