ASSESSING THE CRACKS DEVELOPED IN DEMATAMAL VIHARAYA, BUTTHALA

Department of Civil Engineering, University of Moratuwa

Abstract: Stupas of Sri Lanka stand as proud examples for the engineering excellence of ancient Sri Lanka. Dematamal Viharaya at Butthala is one of the oldest stupas in Sri Lanka built in the 2nd Century BC which is a, 19m tall non-plastered brick structure.

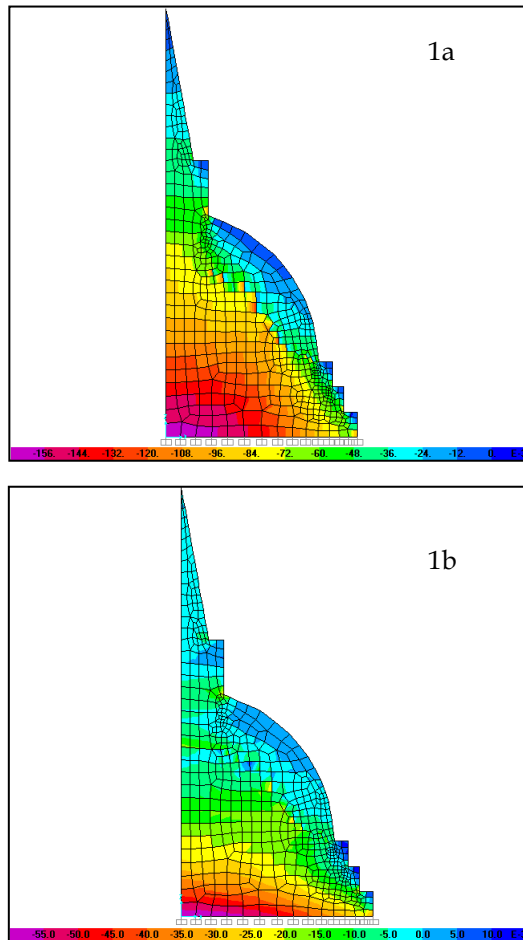
Figure 1: Vertical (a) and Hoop (b) Stresses due to self-weight of the stupa modelled with modern brick properties

Figure 1 shows the vertical and hoop stresses in the stupa. The vertical stresses are wholly compressive in the range of 0.156 Nmm^{-2} to 0.003 Nmm^{-2} and steadily increase from top to bottom. Maximum Compressive stresses can be noticed at the base. Hoop stress is mainly compressive and has a variation similar to the vertical stress, but tensile stresses also can be seen at the outer surface of the dome and in the edge of the pesawalalus but they are less than 0.01 Nmm^{-2} and approximately one fifth of the tensile strength of the modern bricks. So it can

be concluded that the self weight had not been the reason for the cracks.

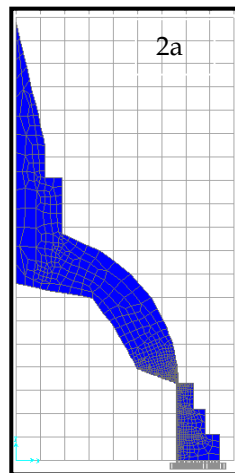
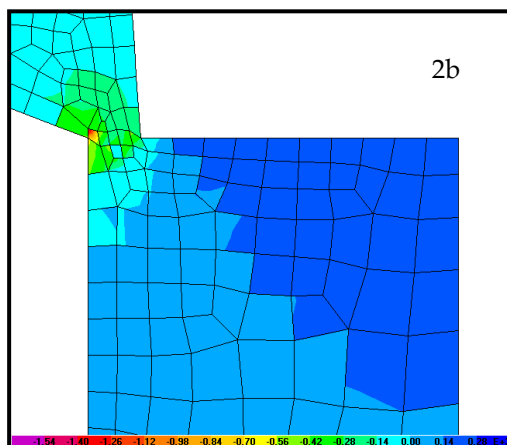
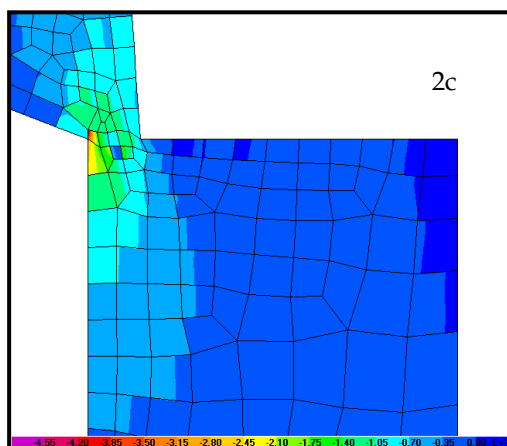
Figure 2: (a) Model used to analyse arch action (b) Hoop stresses at the base of the arch (c) Vertical stresses at the base of the arch

It can be clearly noted that an increase in stress occurs at the base, whether it be vertical, or hoop. In the case of vertical stress, the increase compared to the self weight model with both materials is 30 times higher. The model also shows the development of high hoop tensile stresses in the *pesawalalu* edges thus proving the second part of the hypothesis to be true. The general range of the hoop stress at the *pesawalalu* is 0.14-0.28 Nmm⁻², an increase of 250 times compared to the self weight model. But these stresses are lower than the material strength.

All of the above should be taken into account while arriving at a conclusion. The analysis done helps to come to a conclusion that if the separation of materials result in arch action then it would lead to the development and increase of vertical compressive and hoop tensile stresses which would in turn lead to the formation of cracks. Accordingly remedial actions have been proposed for the stupa to overcome the problem.

Assuming the arch action has in fact induced the formation of cracks, two types of remedial action are proposed. Both methods have been used in conservation works in other stupas which experienced similar kind of failures.

High compressive stresses develop at the base of the new material. This is because the area of the bearing is very small, thus not able to carry the stresses induced by the arch action. By increasing the bearing this problem could be solved. A tie beam around the *pesawalalu* will be able to compensate for the hoop tensile stresses developing at the *pesawalalu*.
