### Overflow Pattern and the Formation of Scoured Region by the Tsunami Propagated in River Channels in Great East Japan Earthquake

Norio Tanaka (Professor, Hydraulic and Environmental engineering, Saitama University, Japan)

**Abstract:** The tsunami caused by the Great East Japan Earthquake on 11 March 2011, with a magnitude of 9.0, caused catastrophic damage to people and buildings in the Tohoku and Kanto regions of Japan. A field survey was conducted to elucidate the damage to river embankments and their hinterlands (residential area) by tsunami propagation in river channels and overtopping of embankments. Three, three, and four rivers in Iwate Pref., Miyagi Pref., and the Kanto Region, respectively, were selected for the field investigation. In the hinterlands, the tsunami came from coast and river, and the situation, including the evacuation of people, became complex. Tsunami inundation patterns were classified by the river capacity and whether a river or sea embankment was breached or not. This will provide useful information for making new hazard maps and planning new cities.

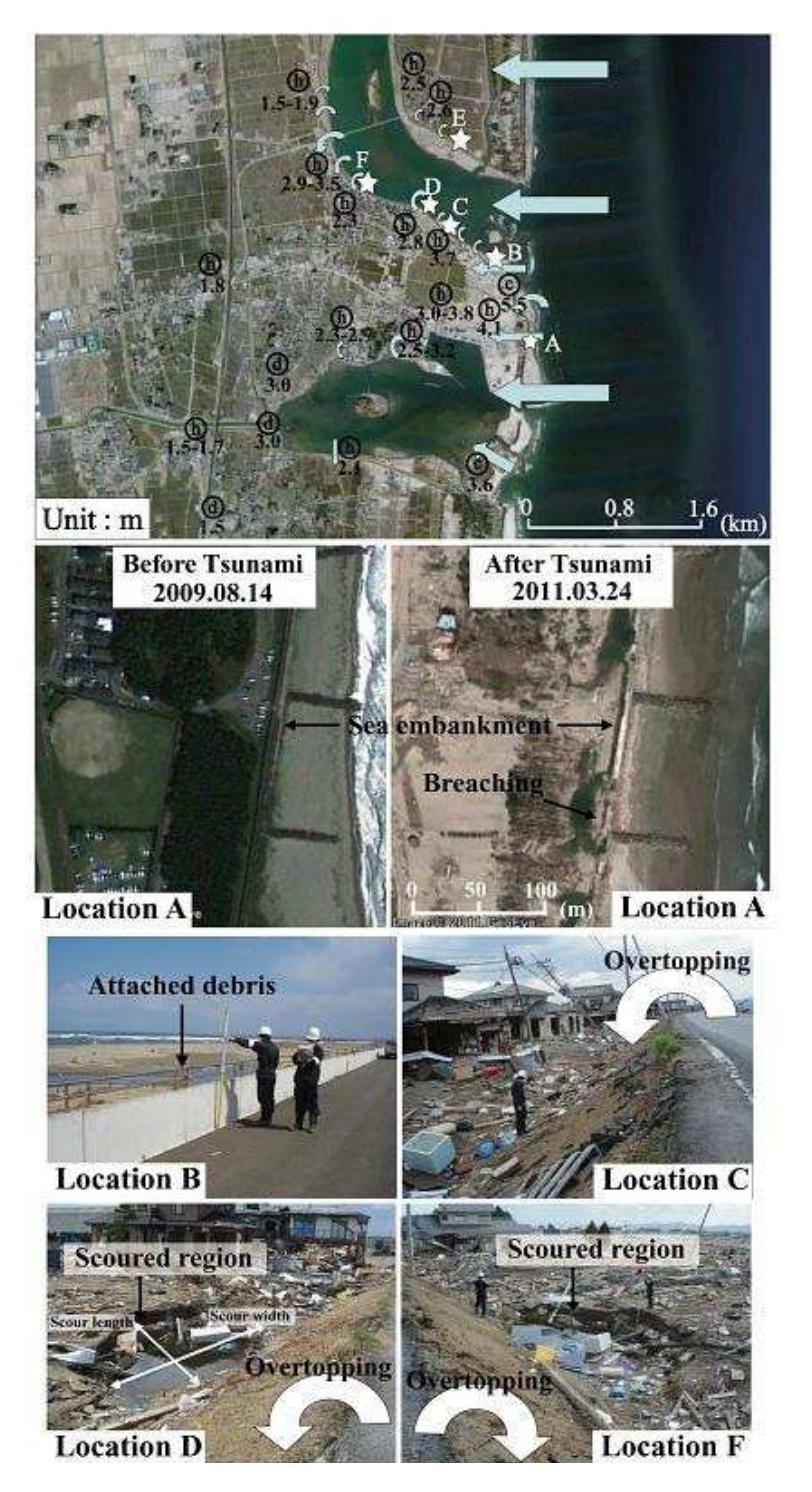
The direction and water depths of the tsunami inundation around the Abukumagawa River are shown in Figure 2. At location A, breaching of the sea embankment was observed. Behind the sea embankment, large areas were scoured by the tsunami overtopping of sea embankment. Near this region, the tsunami water depth was around 5.5 m and the embankment height was 4.8 m. At location B, the overtopping water depth at the top of embankment was estimated to be around 1 m based on the debris attached to the fence on the embankment. Just downstream, the river embankment was also breached by direct attack of the tsunami. The overtopping from the river to the hinterland was severe at location C, but was a little less severe upstream at locations D and E. However, the overtopping became severe again at location F because it was located on the outer-bank side of the river. The extent of overflow was judged from the erosion of the river embankment slope and scoured regions around houses and the broken or washed-out condition of houses. The elevation of the road along the river was higher around location F than in locations D and E, so the difference between the ground level of houses and the road was greater. In location D and E, the road in front of houses had a role to prevent erosion, however location D, downward flow still continued and caused erosion. In that case, the overtopping flow caused scoring and local scour around houses that combined to generate large scour area (Figure 3). Thus, houses around location F were completely washed out, not by the tsunami propagated from seaward, but by the tsunami overtopping the river. Similar overtopping from outer bank of a river was also observed in old Kitakamigawa River.

Figure 2 Damaged situation in Abukumagawa River Basin

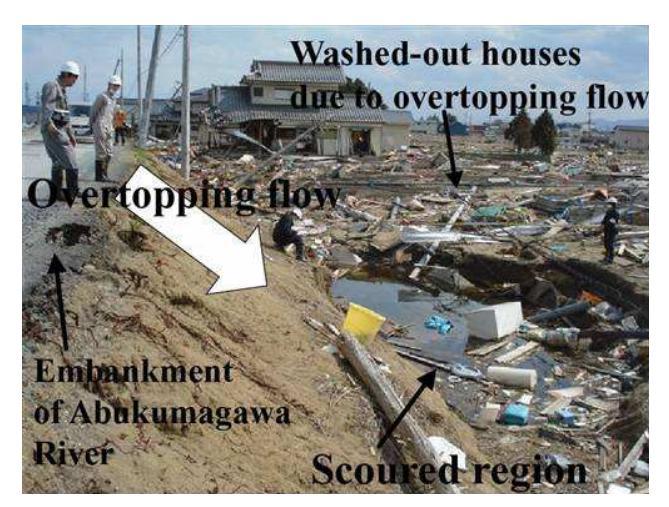
Figure 3 Large scoured region by overtopping flow (Right hand side of Abukumagawa River)

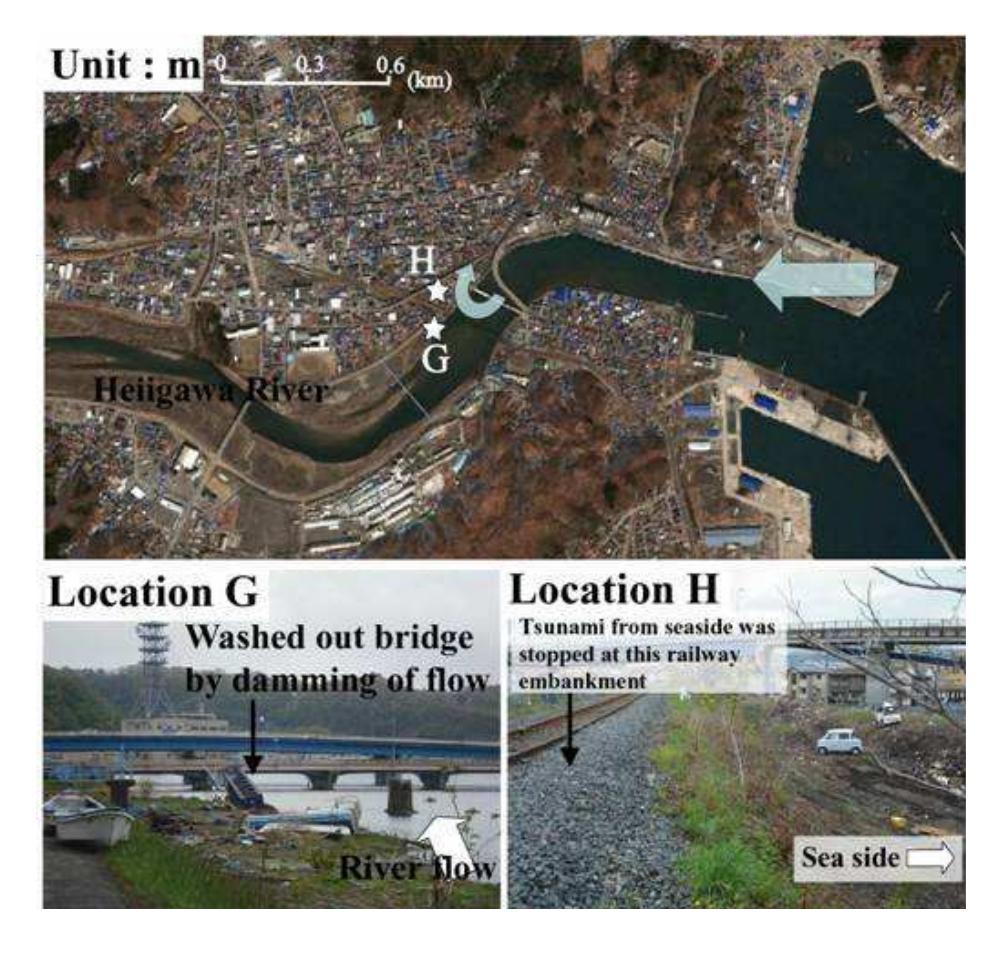
In case of Heiigawa River (Figure 4), a railway bridge which is 1.5 km upstream from the river mouth was washed out after the damming of flow by debris including a ship (Location G). People who temporally

escaped on the railway embankment needed to escape far inland by the destruction of the bridge and railway. Most of the tsunami from seaside was stopped at the railway embankment (Location H), but tsunami also propagated by sewage pipe line, inundated in the inland region of the embankment, and overflown from the upstream river embankment when the railway bridge was broken. This case shows that; 1) bridge has some possibility to be a trigger of the overflow from embankment, and 2) tsunami also propagated from sewage line. This should be considered for the tsunami simulation and hazard mapping.

Figure 4 Damaged situation in Heiigawa River Basin

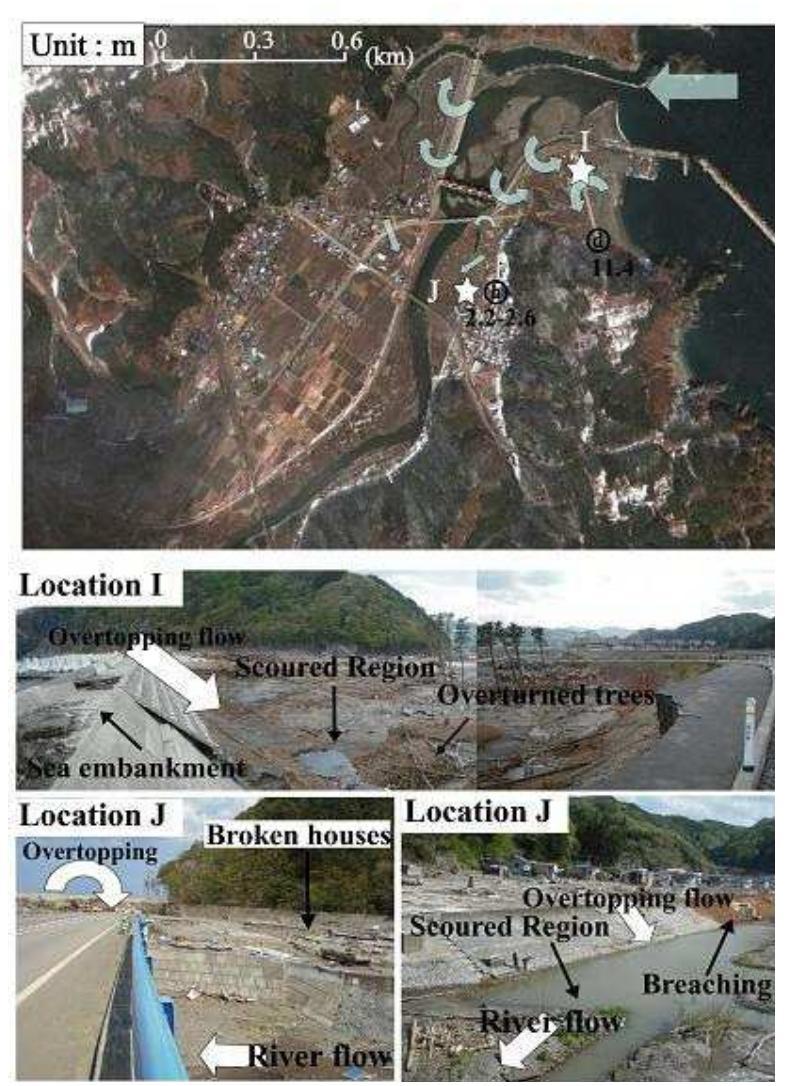
The Omotogawa River (Figure 5) has a tsunami gate and high sea embankment (around 10 m from the

ground on the hinterland side). The overtopping tsunami depth from sea embankment was assumed to around 1.6 m. Many large concrete blocks in front of the sea embankment had been transported by the tsunami, a large scoured region had been generated behind the sea embankment, and the pine trees near the region were overturned (Location I). Most of the houses near the sea and river embankment were washed out by the overtopping flow (Location J). From large scoured regions on floodplain of the river bed, and a scattered region of a broken parapet on the embankment, the breaching was supposed to be occurred from the inland side to the river. Even if a tsunami gate had existed, the tsunami would have been higher than the tsunami gate and the sea embankment; in fact, the tsunami inundation occurred mainly from the high embankment with high potential energy, and washed out or broke the houses. On contrary, in case of a small river in Chiba prefecture, the tsunami was stopped at the gate, because the tsunami height was low in comparison with lwate Prefecturte.

Figure 5 Damaged situation in Omotogawa River Basin

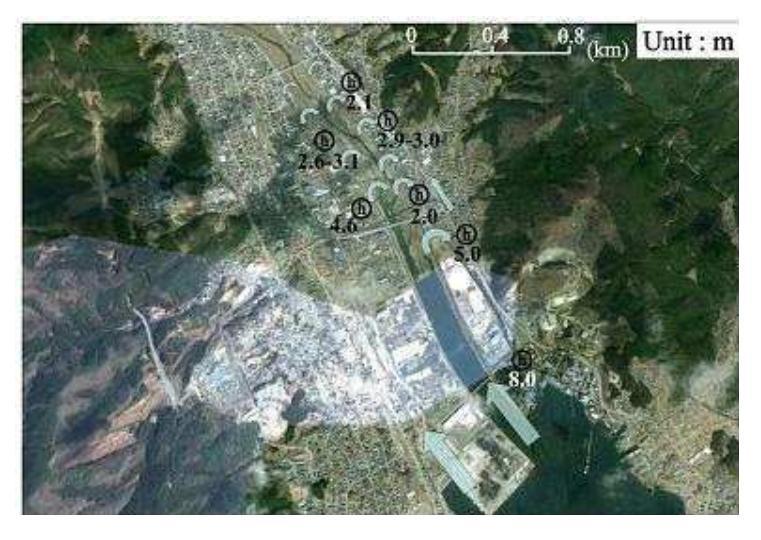
In case of the Sakarigawa River basin (Figure 6), the presence of a road and train embankment changed the direction of most of the tsunami flow intruded from seaward. The tsunami passed through only the culvert of the embankment from seaward to inland, but it continued to overtop the river

embankment. Thus, the people who lived upstream of the road and railway embankments received tsunami inundations from two directions. However, in this case, the tsunami overflow from river embankment itself was not large compared with that of the Abukumagawa River. The inland embankment for railway or road is very useful in some cases and needs to be utilized more, considering the tsunami inundation pattern.

Figure 6 Damaged situation in Sakarigawa River Basin
