# Comparison of Failure Mechanisms of Coastal Structures due to the 2004 Indian Ocean and 2011 Tohoku Tsunami Events

## G. Lim<sup>1</sup>, B. Premaratne<sup>1</sup>, R. Jayaratne<sup>1\*</sup>, M. Marriott<sup>1</sup>and T. Shibayama<sup>2</sup>

<sup>1</sup>University of East London, London, UK <sup>2</sup>Waseda University, Tokyo, Japan \*E-Mail: r.jayaratne@uel.ac.uk, TP: +44 (0)208223 2536

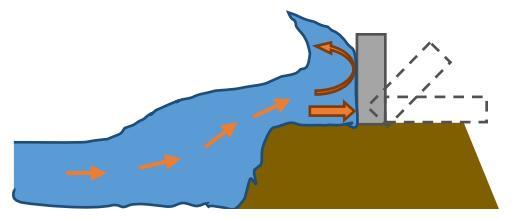
Figure 3: Overturning and parapet wall failure

These two failure mechanisms have been grouped together because they work more or less in the same way. It was found that the majority of parapet walls that did fail (this failure mechanism was found to be very common), failed as a result of wave impacting forces. As it is shown in Figure 3, when the impacting forces imposed by the waves exceeded the resisting strength of the parapet wall, the structure was cracked or in some cases destroyed completely. This is very much the same for the overturning of structures such as seawalls and breakwaters. It was found that in many cases where structures failed by overturning, they were caused by the impacting force of the tsunami waves; whether it was the run-up process or the draw-down process. When the overturning moment induced by the waves exceeded the restoring moment, the structure overturned. It was also that hydrostatic forces induced found by differences in water level either side of the structure often resulted in overturning failure.

Wave impact causing structure to fail by overturning (Caused by both run-up and draw-down processes).

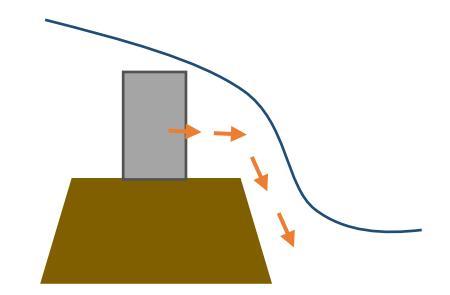
#### Figure 4: Sliding failure

Sliding failure was the major failure mechanism by which breakwaters failed. As tsunami waves overtopped the structure, a difference in water level on either side of the structure induced lateral hydrostatic forces. These forces pushed the structure, destabilised it and in many cases caused them to fail by sliding.

Pressure difference in either side of the structure causes hydrostatic force large enough to cause the structure to slide (Caused by both run-up and draw-down processes).

It was noted that scouring would most probably have occurred and destabilised the mound, making it more susceptible to sliding failure. The hydrostatic forces and the presence of scouring were the possible factors in sliding failures. By computing shear forces induced by scouring, relevant measures could be taken to resist these forces. Hydrostatic forces were also calculated in this paper. Based on the calculations, it can be said that structures such as breakwaters would need to be designed to be able to resist against, on average, a maximum force of 1710kN/min regions of Japan, and 611kN/m for regions surrounding the Indian Ocean. Now it would seem that building a structure to resist such large forces would be difficult and expensive. It could also be argued that such a strong structure would not be necessary as hydrostatic forces that high would not occur regularly.

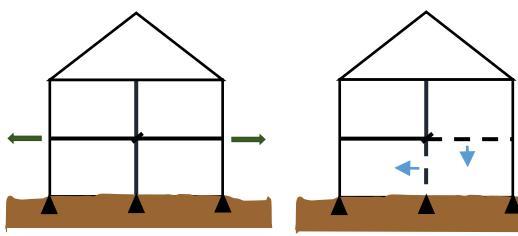
Figure 7: Total disintegration

Total disintegration was found to be the major failure mechanism by which structures failed in regions of Indonesia and Thailand especially, under the 2004 Indian Ocean tsunami. It was found that these failures were often caused by systematic failure whereby foundation failure, beam and column failure, joint or wall failure eventually led to the total collapse of the structure. Unlike the wall failures shown in Figure 6, beams, columns and joints serve an essential role in the distribution of loads in a structure. In many cases, when the beams or columns or joints were damaged (due to seismic action, hydrodynamic forces, debris impact etc.) the overall stability of the structure was severely affected. Such instability, when not repaired quickly, often led to collapse. In other cases structures were made unstable and vulnerable by beam, column and/or joints being damaged, and then completely swept away (totally disintegrated) by wave or debris impacts. In other cases structures completely disintegrated under seismic excitation alone, before the waves even reached them. It was more commonly observed however where structures that had already been weakened by seismic excitation from the earthquake, were completely swept away by the tsunami waves.

One of the fundamental reasons why so many structures were devastated by this failure mechanism was the poor quality of design and construction. It was observed that even though a few structures were structurally well-engineered, they were not built to withstand seismic forces. This may have been because the surveyed areas were previously not as prone to seismic activity as Japan.

1. Seismic forces act on the frame (beams, columns and joints) of the structure.

Seismic excitation causes damage to the frame, leaving the structure unstable and vulnerable to collapse.
 Tsunami wave impacting forces and hydrodynamic forces sweep away

torces sweep away weakened/vulnerable structure. The result is' total disintegration'.

Thus, when designing for future structures, it would be necessary to incorporate concepts of earthquake engineering into the structures to be at the least somewhat resistant to seismic action. It was discovered that many structures had strong beams and weak columns, which is seen to be one of the worst possible combinations in earthquake engineering. Ideally, a structure would need to remain stable and strong enough to withstand the hydrodynamic forces imposed by tsunami waves even after seismic excitation. According to the calculations carried out by the authors, a structure of surface area 100m<sup>2</sup> in the Indian Ocean regions would need to be able to withstand drag forces of up to about 6.8 MN. Now as was the case with the hydrostatic forces, it would be difficult to design a structure to withstand such a force, and even if it were possible it would likely be very expensive and inefficient. An alternative would be to develop methods of minimising the hydrodynamic forces to some extent and also to incorporate strengthening measures to structures so that the combination of the two methods would allow for structures to resist the hydrodynamic forces without failing.

It is fundamental when designing for structures to be resistant against seismic excitation, to have a frame with strong columns and weak beams (the opposite of that found in the structures in Indonesia). The reason for this is earthquakes usually cause a lateral movement of the earth. Such excitation is known to cause stiff columns to snap and flexible columns to sway in the direction of the seismic movement. If columns are strong, they are able to withstand the seismic action without snapping/breaking. Beams on the other hand connect column to column. When columns begin to sway due to seismic excitation, the beams if too stiff would simply snap. By adopting a strong columns and weak beams configuration, the structures would become more resistant to seismic excitation. This configuration could easily be applied to future design and construction and also to already existing structures by using various methods of reinforcement. It was found through interaction diagrams that the columns observed in regions of Thailand could not even sustain half of the moments that were imposed, before failing. But columns that had lateral bracing provided by inplane infill walls were found to survive against the seismic action as well as the tsunami waves. Such information could be taken into consideration and additional lateral bracing could be applied to

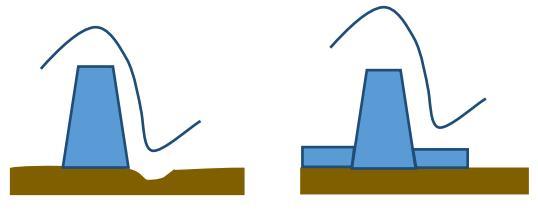
Figure 8: Toe scour (left), Protected toe (right)

In this study, it was found that toe scour posed a significant threat not because the scouring itself rendered the structures unusable, but because they led to the destabilising of the structures and made them more susceptible to overturning and sliding failures. As this is the case, two logical approaches could be taken in order to strengthen the structures against failure:1) Strengthen the toe region of the structures to avoid/resist erosion in the first place,2) Second approach would be to make the structure more stable so that even if scouring were to occur, it would not be enough to cause the structure to fail.

If the first approach were to be taken, various materials could be used to create an elongated toe part that would come into contact with the rapidly overtopping flow. If the toe of the structure is elongated as shown in Figure 8, the structure is more stable in two ways;1)The elongated toe part will be the part of the structure the rapidly overtopping flow will impact [as opposed to ordinary soil as shown in Figure 8 (left)]. This means that worst case scenario, the elongated toe part will be damaged, but the soil underneath will not be scoured and the structure will therefore remain stable. The elongated toe effectively works as a sheet of armour protecting the soil on either side of the structure against scouring. Considering that such methods could prove to strengthen the structure against failing completely, it could be deemed a worthwhile investment despite the costs. 2) The elongated toe part of the structure is directly connected to the base of the structure, giving it more stability against overturning failure. It is commonly known that structures or objects with a wider base are more difficult to overturn. By implementing such elongated toes to these structures, they would be protected against the effects of both scouring and overturning failure. In order to make this method affordable and sustainable, cheap but durable materials could be used, perhaps materials that are recycled/recyclable or reusable such as aggregates.

These elongated toe parts could also be designed to be removable/ attachable to the main structure. This would allow for just the toe parts to be replaced in the event of one of them being damaged, rather than having to repair/replace the whole structure which would be more expensive and inefficient. This would also be beneficial as such parts could be added to already existing structures as well as ones that are to be built in future. One thing that should be considered however is the method by which these attachable parts will be held in place. In crown armour failure, it was understood that the tsunami-induced negative pressures lifted and removed the crown armour from their existing places. It is possible that such negative pressure could remove these attachments if they are not securely fixed to the structures.
