STRENGTH ASSESSMENT OF STEEL TOWERS

Department of Civil Engineering, University of Moratuwa

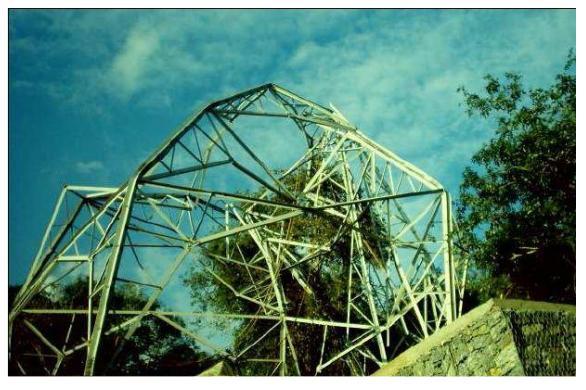
Fig 1 Beliaththa 70m antenna tower collapse

Description of antenna tower	Design as	Possible reasons for failure	Failure pattern info:
70m high at Beliatta (Mobitel) <i>See Fig 1</i>	Four legged steel lattice structure, designed for 10sqm antenna area	Improper erection procedures adopted. Erected without providing any of inner plan bracings. The use of temporary guy ropes in unsymmetrical manner.	Collapsed at second panel
70m high at Mihintale (Sri Lanka Telecom) <i>See Fig 2</i>	Four legged steel lattice structure, designed for 10sqm antenna area.	Due to tornado situation	Collapsed at second panel Twisting of the structure in its own axis during the collapse
70m high at Gampaha (Mobitel) <i>See Fig 3</i>	Four legged steel lattice structure, designed for 10sqm antenna area.	Overloading of antennas Affecting fault of design Fabrication detailing error	Collapsed at second panel
70m high at Horowpatana (Sri Lanka Telecom) <i>See Fig 4</i>	Four legged steel lattice structure, designed for 10sqm antenna area.	Due to direct hit by a Tornado Overloading due to large cable tray	Twisting around its own axis

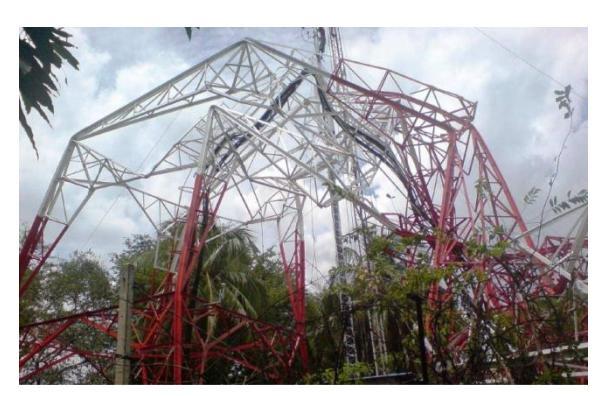
Fig 2 Mihinthale 70m antenna tower collapse

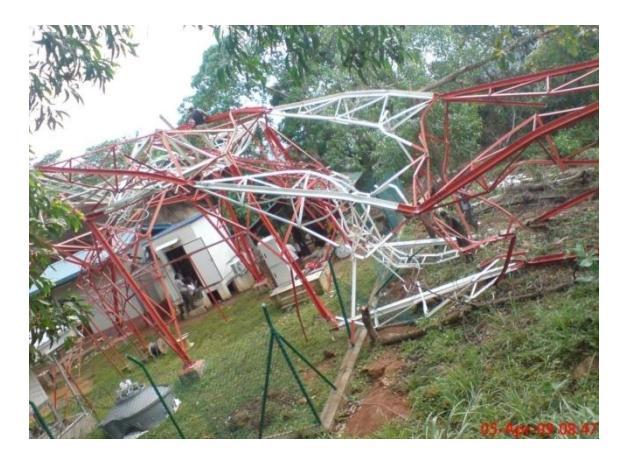
Fig 3 Gampaha 70m antenna tower collapse

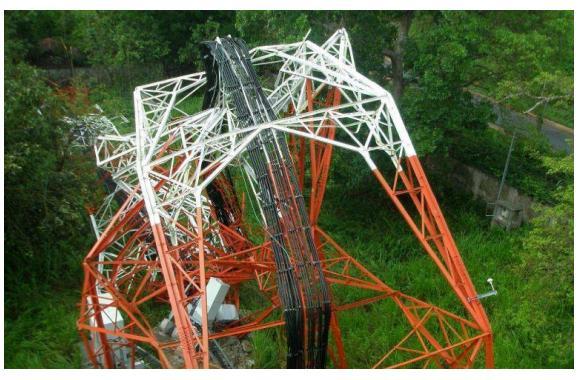
Fig 4 Horowpathana 70m antenna tower collapse

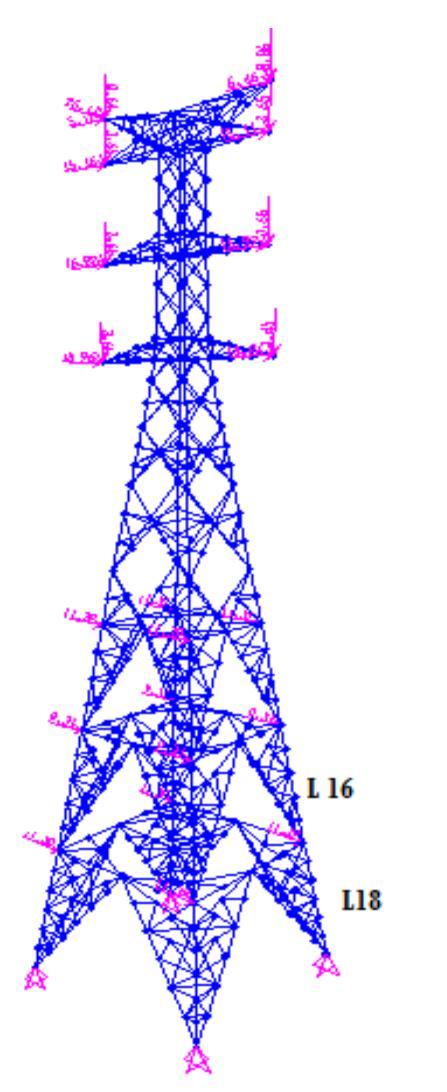
The transmission tower failed while testing under normal condition- maximum vertical load (lc11) condition and normal conditionminimum vertical load (lc10) condition. Under lc 10 bottom panel leg member failed due to compression buckling. Failed members (100x100x8) were replaced with larger members (100x100x10) and then loaded for lc10. No failures occurred so loading proceeded to lc11. Under lc11 second panel leg member failed due to compression buckling. Reason for the failure is due to improper design of tower.

For bottom panel leg, 100x100x8 angle section compression capacity is 456 kN and for

100x100x10 angle it is 564 kN (depends on member lengths). From analysis axial compression forces of 352 kN for lc2, 462.8 kN for lc10 and lc11 and 486.5 kN for lc12 were obtained for bottom panel critical leg.

Fig 5 Transmission tower geometry and failed legs

For second panel leg, 100x100x8 angle compression capacity is 416 kN. For second panel critical leg, compression force of 317.5 kN for lc2, 405.6 kN for lc10 and lc11 and 421 kN for lc12. Analysis results exhibited significant bending moment in all above cases (for both panel legs). So buckling is possible in critical case.

Above results clearly indicates the failure of same members under the same loading cases.

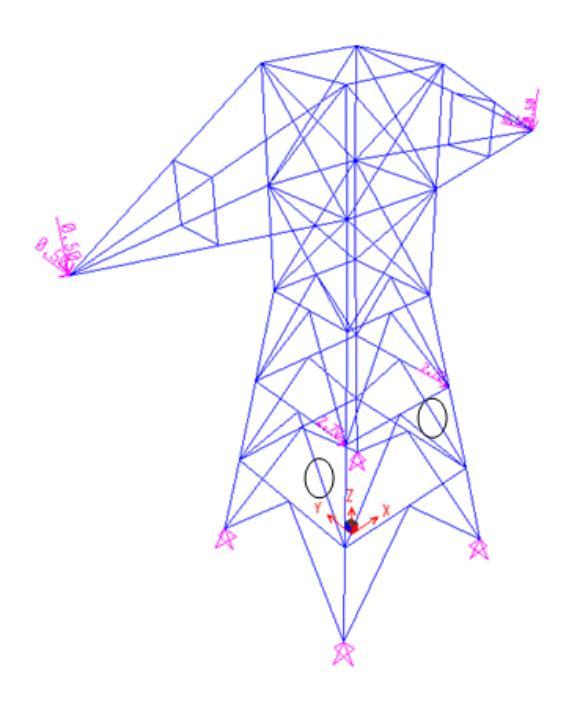
Fig 7 Generated simple model and proposed loading and member failures

Suitable nodes were selected to be loaded and failure loads and failing members were identified (*see Fig 7*). Two nodes in legs were selected to apply horizontal force and two arm nodes were selected to apply a nominal quantity of both horizontal and vertical loads. From analysis and design check using SAP 2000 a force of 4.1 kN on leg nodes caused failure in second panel compression bracing, as shown in figure 7.

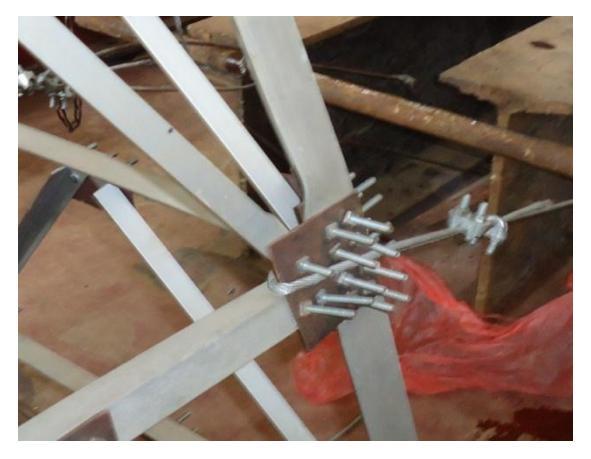
Tests resulted in completely different failures. When load on leg nodes are increased to 3.5 kN second panel horizontal member got bent (*see Fig 10*) and third panel leg member got bent (*see Fig 9*). Loading procedure continued and second panel tension member bolts failed at the same load i.e. 3.5 kN.

Fig 9 Bent leg of third panel

Further analysis was done and it was found that yielding of bolts caused above bending failures. Due to bolt yielding, tension members were not effective. To stimulate this in SAP 2000, same model without those tension carrying members was generated and analysed. Results predicted failure of horizontal members and leg members, when load on leg node was 3.5 kN. The model without those tension members was further analysed to find the loads on leg nodes to cause the failure. When loads on leg nodes were increased to 2.5kN second panel horizontal members failed due to bending.

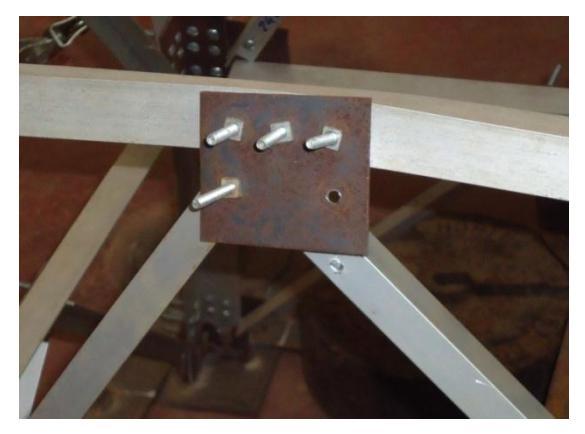
Fig 10 Bent horizontal member and bolt failure

Bolt shear capacity was tested with Hounsfield tensometer by pulling two steel plates fixed together by a single bolt. The failure occurred under a load of 3.6 kN. This value was checked with the tension force induced in that bolt under failure load. Then whole model was analysed under actual failure load that is 3.5kN. A tension force of 3.28 kN was obtained in the failed connection. As the difference is not significant the cause was ensured.
