CLAY BRICKWORK AND ITS POTENTIAL CONTRIBUTION TO SUSTAINABLE INFRASTRUCTURE

Stephen Garrity
University of Leeds, United Kingdom
E-mail: s.w.garrity@leeds.ac.uk

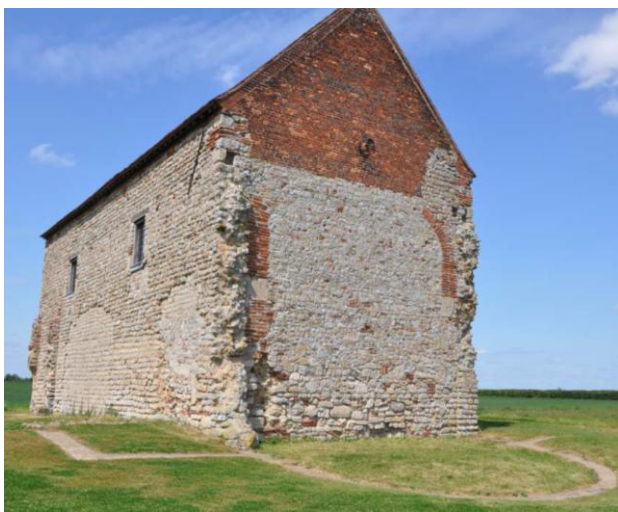
Figure 1. The chapel showing an exposed original clay brick column and the remains of an arch (the roof and gable walls are not original construction).

The principal point to be made is that the clay and stone masonry used to construct much of this building seems to date from the 3rd century yet much of it remains intact today. It is very likely that no major maintenance or repair work was carried out on the masonry walls of the building

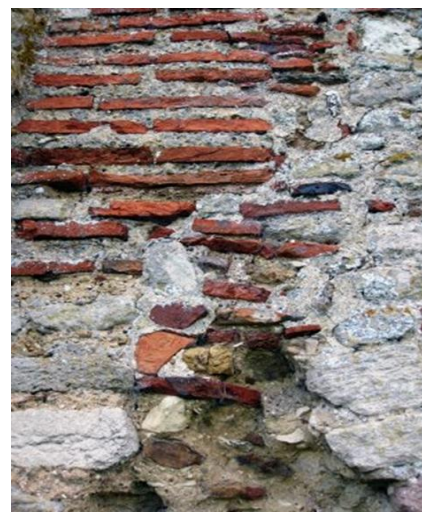
Figure 2. Typical Roman clay brick (or tile) construction.

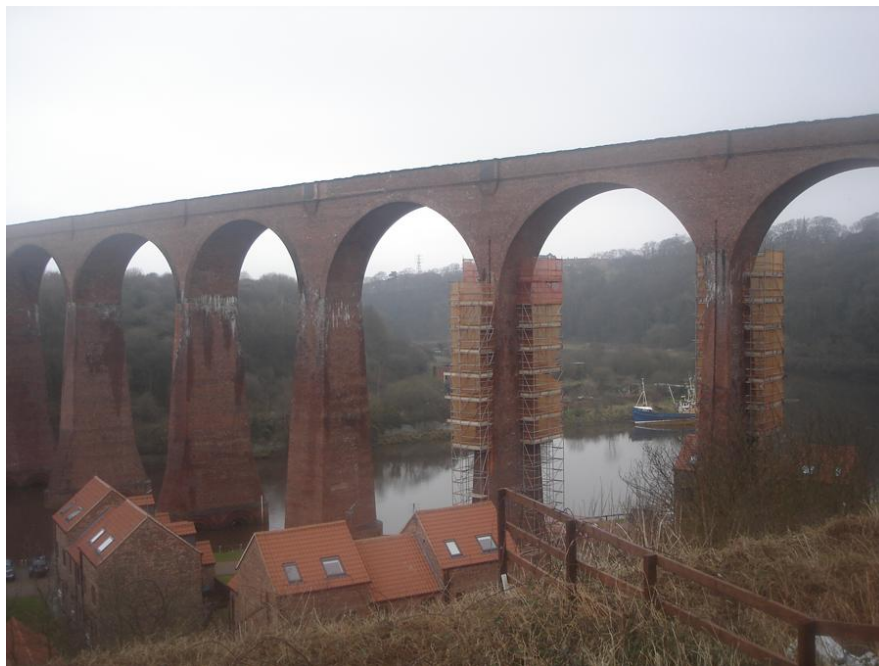
Figure 3. Larpool viaduct.

Larpool viaduct was originally constructed to carry the Scarborough and Whitby railway across the River Esk in Whitby, North Yorkshire, England; see Figure 3, below. The railway was built to link the two thriving coastal holiday resorts of Whitby and Scarborough. Construction of the railway started on 3rd June 1872 and the completed line was officially opened to rail traffic on 16th July 1885; the total cost of construction was £649,813 (Fox 1885-86).

The viaduct is of clay brick construction. It is approximately 279m long and consists of thirteen clay brick segmental arches each spanning just over 18m with a rise of approximately 8.4m. The arches are supported on solid clay brickwork piers of tapered construction. Typically the cross-sectional (or plan) dimensions at foundation level are 8.0m x 2.8m reducing to 5.18m x

By 2006, visual inspections had revealed that numerous pieces of clay brickwork had spalled from three of the piers of the viaduct. These posed a threat to the health and safety of the occupants of a number of new houses constructed on one of the banks of the River Esk, beneath the viaduct; see Figure 3. As a result, the viaduct owner let a contract to repair the three piers. The author was appointed by the owner to provide specialist advice on the proposed repairs and the methods employed by the repair contractor (Garrity 2010). As part of these responsibilities, the author carried out an initial inspection of the viaduct early in 2007 which revealed the following:

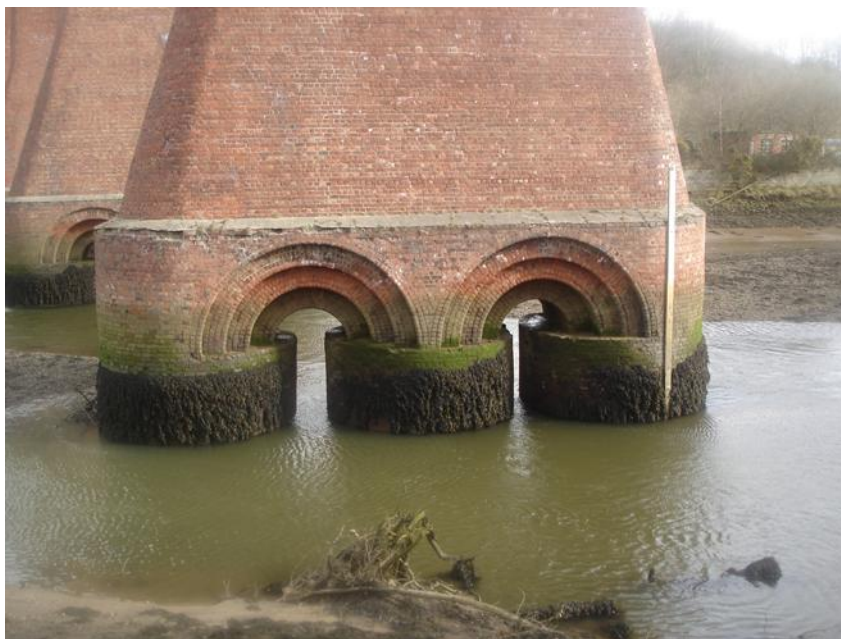
Figure 4. Solid brickwork piers of Larpool viaduct.

A detailed description of the construction of the viaduct is given by Fox (1885-86). Of particular note were the problems encountered when constructing the foundations in the River Esk and the centring used for the construction of the arches. The near-surface ground conditions consist of alluvial deposits of sand, mud, silt and silty clay. The foundations were constructed on a thick layer of shale which is part of the sedimentary formations of the Middle Jurassic period. For each of the piers constructed within the tidal range of the River Esk, three brickwork caissons of cellular construction were sunk down to the shale. The voids in the caissons were subsequently filled with mass concrete and the three caissons were connected by two multi-ring arches on which the piers were subsequently built, as shown in Figure 4.
