DEVELOPMENT OF EXPERT SYSTEM FOR THE SEISMIC VULNERABILITY OF EXISTING MASONRY STRUCTURES

Padmal H.M.S.S.*, De Silva Sudhira and De Silva Subashi

Faculty of Engineering, University of Ruhuna.

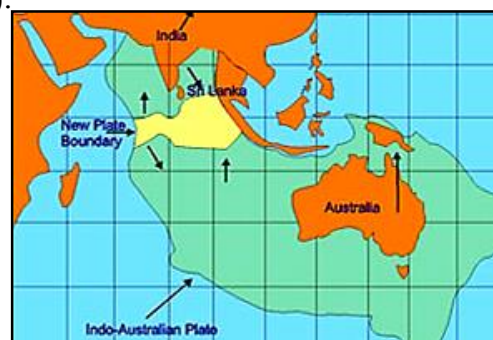
Fig 1: The Indo-Australian seismic plate and the splitting path

Recent geological studies found convincing evidence for a long suspected geological phenomenon that the Indo-Australian plate is indeed splitting as shown in Figure 1. It is creating an intra-plate just about 400-500km from the southwest coast of Sri Lanka. Hence there is a potential of increasing seismic activities in Sri Lanka and need to consider the design requirement (Pradeep et al. [2]).

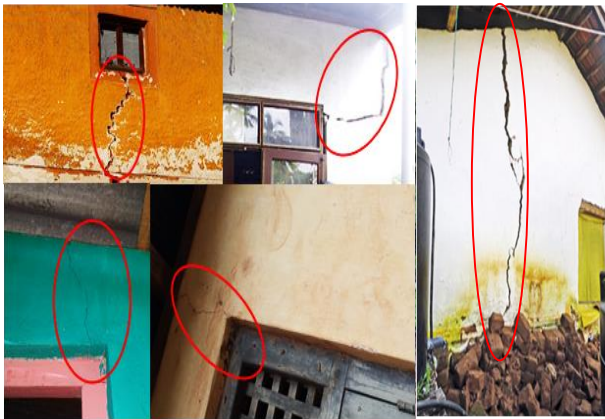
Fig 2: Observed failures of masonry structures - visual observation survey- South East Sri Lanka

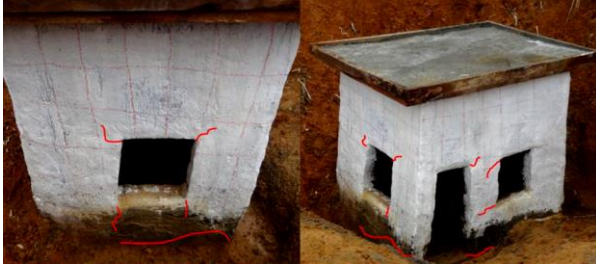
Fig 9: Observed crack lines after blasting

Small hair cracks were visible on the opening corners and the bottom level of the model house (Figure 9).

Crack width was measured by using standard crack gauge and most of the cracks are recorded as 0.1mm, 0.15mm. Major cracks clearly identified near the doors and windows openings. Other than that a linear crack line propagates through the bottom wall level where the bricks connected to the foundation. Diagonal crack appeared from the top and bottom of window openings.

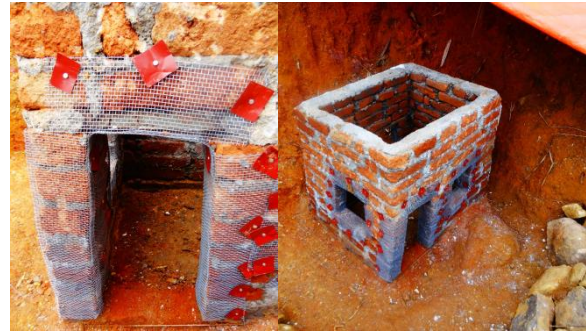
Fig 10: Observed crack lines after blasting

To idealised a proper retrofitting techniques to reduce the crack propagating at corners and openings; another ferrocement retrofitted modal masonry house was built in the same place (Figure 10).

After the same experiment procedure, it was observed that no any visually observed crack propagates on the masonry walls after steel mesh retrofitting.
