Field application of FRP material in Kentucky

Abheetha Peiris,
University of Kentucky
(email: abheetha@engr.uky.edu)

Abstract

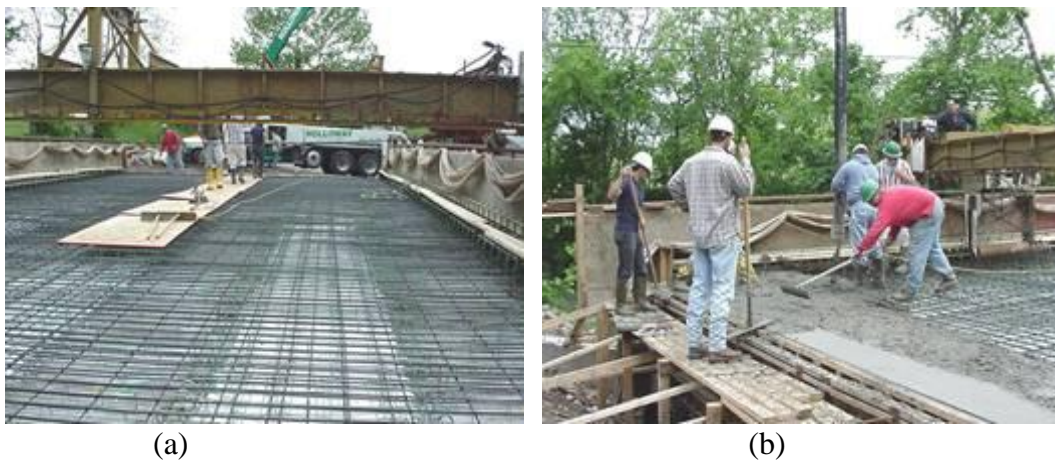
Figure 2: (a) CFRP reinforcements as longitudinal and transverse reinforcement in both the top and bottom mats; (b) concrete placement

The Two Mile Creek Bridge is located on Elkin Station Road in Clark County, KY. The 9.45 m (31 ft.) wide and 18.6 m (61 ft.) long bridge in Figure 2 is reinforced with Carbon Fiber Reinforced Polymer (CFRP) reinforcement (Hill et al., 2003). All longitudinal and transverse reinforcements in both the top and bottom mats are CFRP bars. The bridge is being monitored on a regular basis (i.e. evaluate crack formation, crack width, crack propagation, etc.). To date, no sign of distress has been reported and the bridge is reportedly in excellent condition.

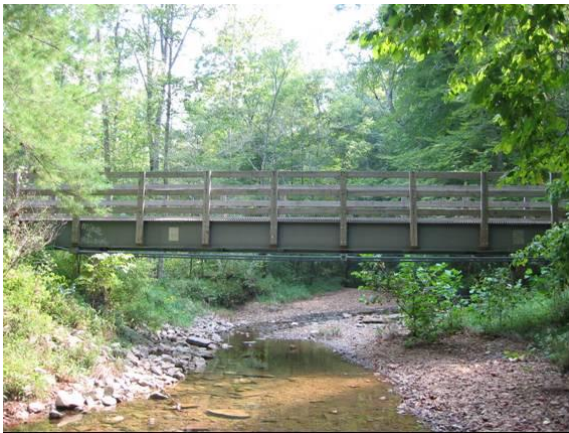
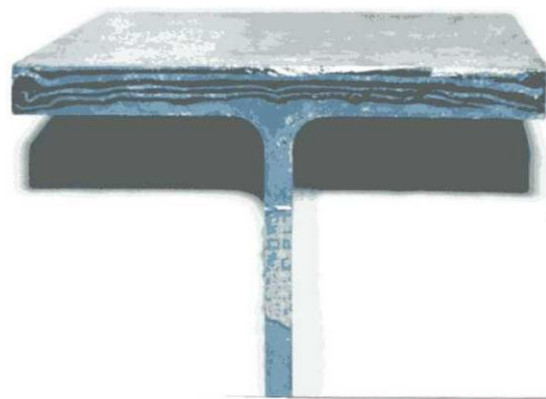
Figure 3: (a) Clear Creek Bridge in the Daniel Boone National Forest; (b) Cross section of the flange of the hybrid composite I-beam. The carbon fibers are seen as dark horizontal lines

A pultruded FRP composite I-girder pedestrian bridge (Fig. 3) was constructed in 1996 over the Clear Creek in the Daniel Boone National Forest near Cave Run Lake in Bath County, Kentucky, USA (Szak et al., 1999). The main load carrying members for the bridge are two 61 cm deep hybrid composite I – girders. These girders were made of glass fibers in web and flanges with embedded carbon fibers in flanges. The addition of the carbon fibers in the flanges produced a 128 % increase in the rigidity of the beam, and since the design was controlled by deflection limitations, the number of girders was reduced from four to two. Many new features were incorporated in this bridge. These features include: (i) the use of a hybrid carbon/glass fiber reinforced polymer (FRP) I-beam section; (ii) the use of fiberglass sucker rods as supports for a bridge; and (iii) the use of spliced composite I-girders in a bridge.

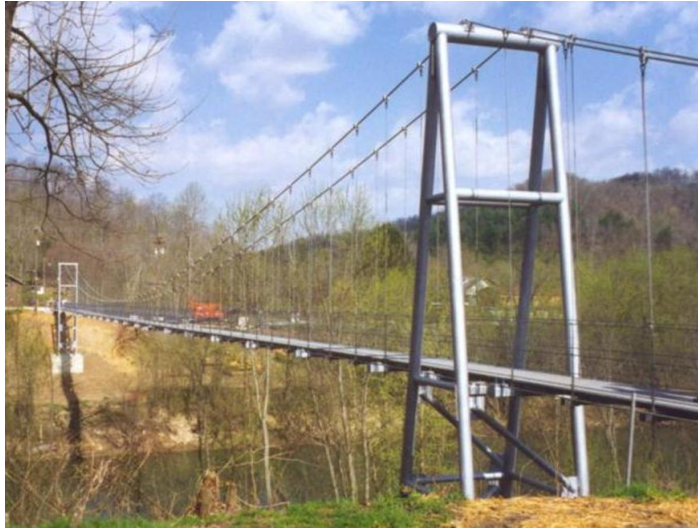
Figure 4: Swinging Bridge over Big Sandy River

A pedestrian swinging bridge that is 128 m long and 0.92 m wide was constructed in April 1999 over the Big Sandy River in Johnson County, Kentucky (Fig. 4). The superstructure in the suspension bridge is made from pultruded GFRP components. The deck is composed of an

open grid resting transverse box section, which in turn rest on longitudinal box sections.

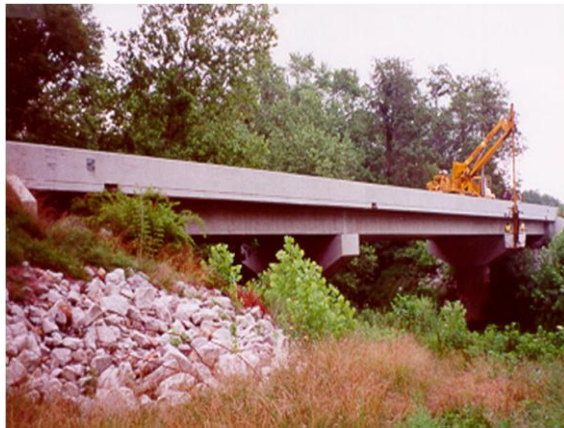
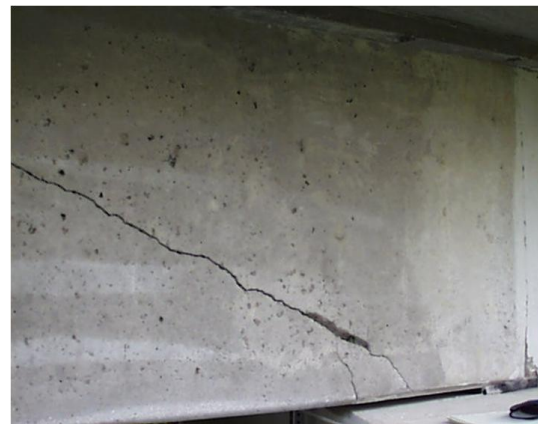
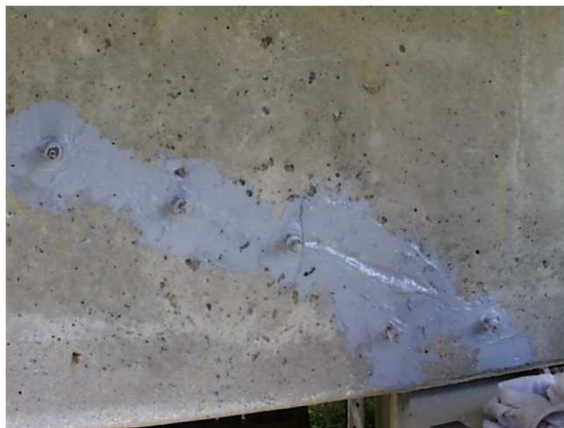
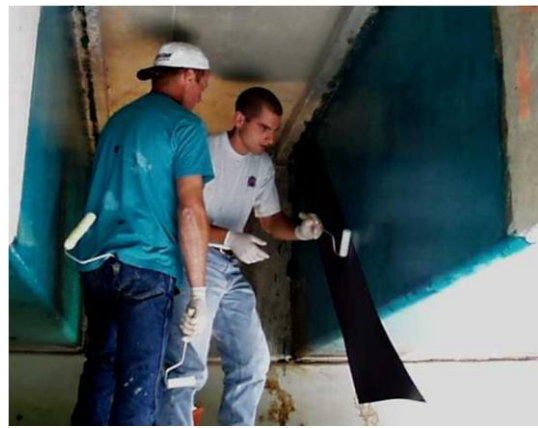
Figure 5: (a) Carter County Bridge; (b) Shear cracking in prestressed box beam; (c) Filling cracks with epoxy; (d) Attaching CFRP fabric to concrete

A routine inspection on the 3 span bridge on route KY3297 over Little Sandy River in Carter County, Kentucky conducted in April 1996 found significant diagonal shear cracks that were as wide as 3.2 mm, and 1.8 to 2.4 m long had formed in all precast prestressed box beams at both ends of the center span (span 2). Subsequent inspections revealed that the shear cracks in span 2 were propagating at an alarming rate, and new shear cracks were also beginning to develop in spans 1 and 3. In addition, the re-evaluation confirmed that the box beams were indeed under-reinforced in shear. The retrofitting process for the Bridge using CFRP fabric (Simpson et al., 2006) began in September 2001 and was completed in October of 2001. The process was performed in two phases: (1) crack repairs; and (2) application of CFRP fabric. The goal of crack repairs was to partially restore the capacity of the beams, and the application of CFRP fabric was to strengthen and compensate for shear deficiency.

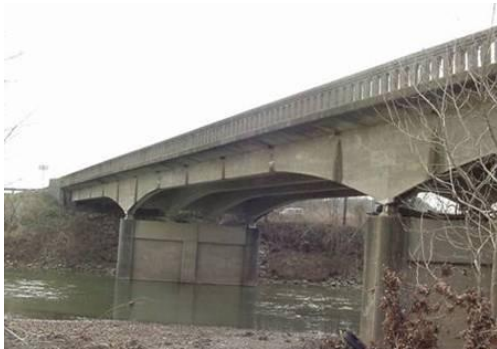
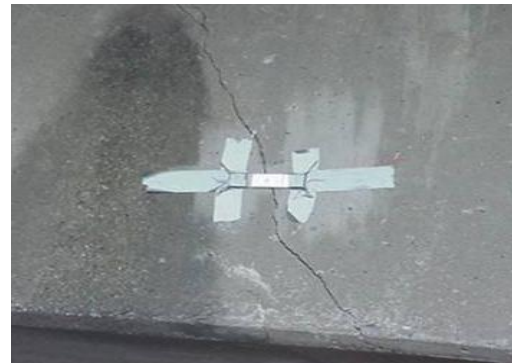
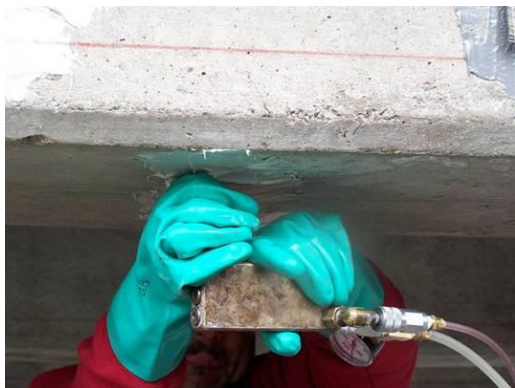
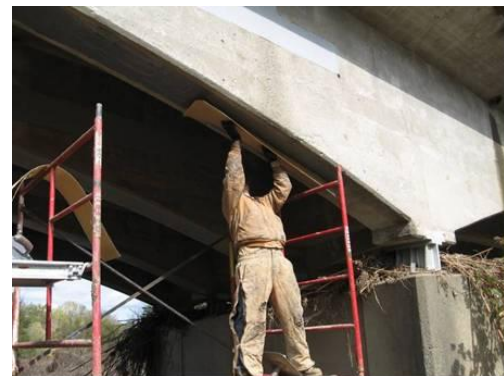
Figure 7: (a) Nelson County Bridge; (b) Diagonal cracking in concrete beams; (c) Crack filling; (d) Attaching SFRP fabric to concrete

The Washington and Nelson County bridges are located on route US 150 in Kentucky. The haunched reinforced concrete girders have developed diagonal cracks near or at the transition of the variable-and-constant depth regions. Steel fiber reinforced polymer (SFRP) sheets were selected for the retrofit. Repair to the reinforced concrete girders was carried out by bonding the SFRP sheets to the vertical and bottom faces. The retrofit was completed in June 2007. Crack gauges have been installed to monitor potential movement and to evaluate the effectiveness of the retrofit.

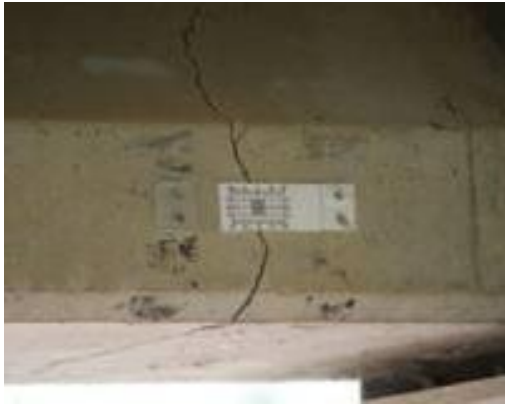
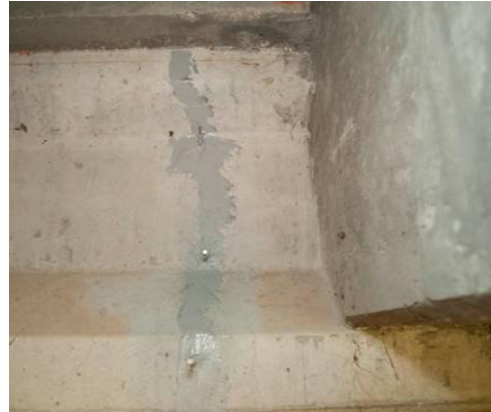
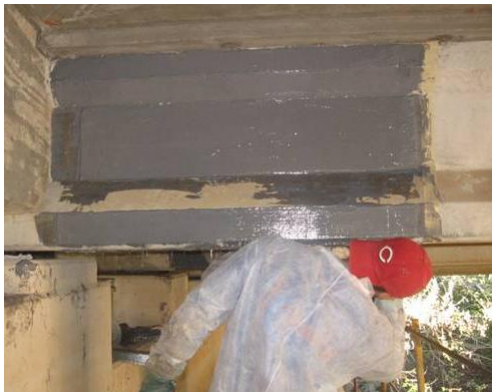
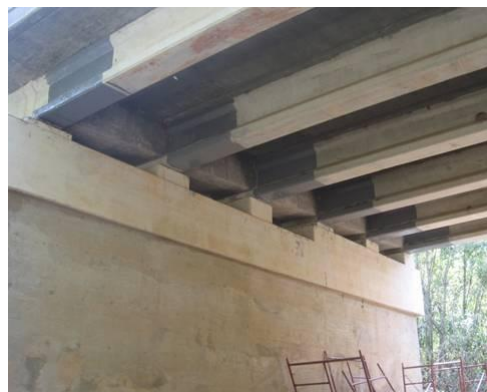
Figure 8: (a) Cracks in AASHTO Type I girder; (b) Cracks ready to be filled; (c) Application of SFRP on concrete beam; (d) A repaired section of Hart County bridge

The KY 218 Bridge in Hart County is a three span bridge having 6 AASHTO Type I PC girders in each span. The girders have developed cracks extending from the bottom flange to the web or top flange at various locations in the three spans of the bridge. The cracks were widening with time. High strength steel fiber reinforced polymer (SFRP) fabric was attached to the vertical and horizontal surfaced of the PC beams to halt the growth of cracks.

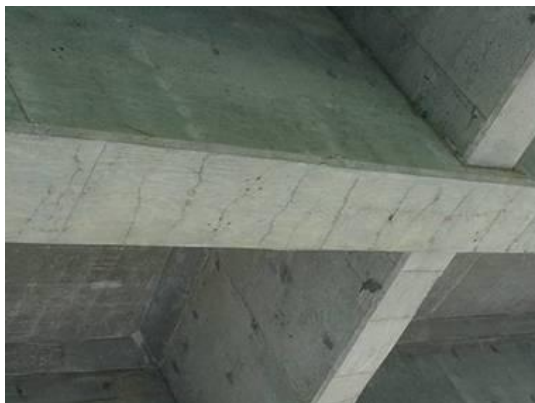
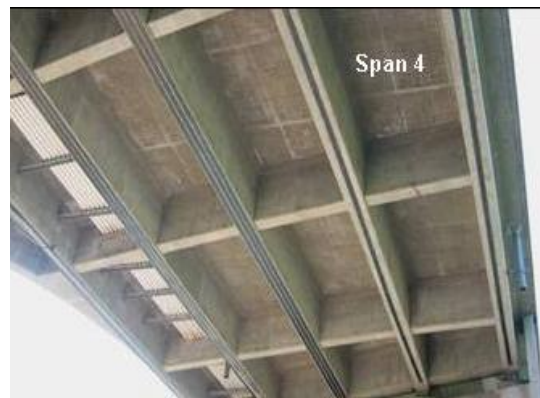
Figure 9: (a) Louisa-Fort Gay Bridge; (b) Flexural cracks in RC girder; (c) Beams retrofitted with CFRP laminates

The Louisa-Fort Gay Bridge is located in a small mining community of Lawrence County in Eastern Kentucky. The 12-span continuous bridge structure consists of composite concrete deck-steel girder spans and reinforced concrete middle spans that comprise an intersection for traffic coming from three different directions. Bridge inspection indicated that flexural cracks developed in the RC girders due to heavy coal truck loads. Weigh in motion scales measured trucks weighing in excess to 1000 kN (225 000 lb). The amount of CFRP laminates needed to strengthen the beams was determined via moment-curvature analyses (Choo and Harik, 2007).

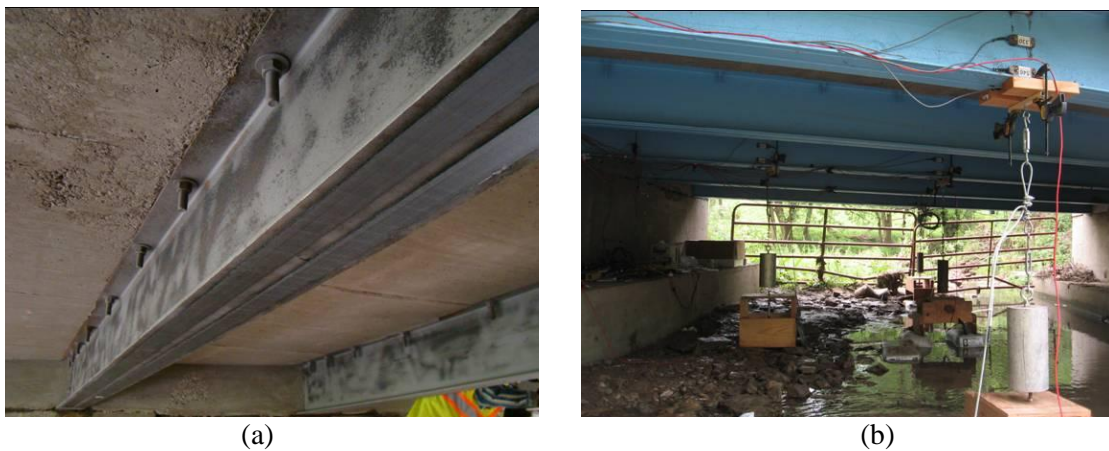
Figure 10: (a) Bridge girder with post-installed shear studs and ultra high modulus CFRP laminates; (b) Instrumentation for field tests

The KY 32 Bridge over Lytles Creek, located in Scott County KY, is a single span steel girder bridge with a non-composite reinforced concrete bridge deck. A load posting of 12.7 tonne (14 ton) was on the bridge before strengthening. Shear studs were post installed between the steel girders and the concrete deck to make the bridge deck composite with the girders. Following the placement of the shear studs, ultra high modulus CFRP laminates were applied, to the top and bottom, of the bottom flange of the steel girders. Field tests were conducted before and after the installation of the shear studs to verify the effectiveness of post installed shear studs (Peiris et al., 2010). The laminates were applied in April 2010 and field tests were carried out after the laminate application to determine the increase in the load carrying capacity and the reduction in maximum deflection after the strengthening.
