Cyclic Testing of Hollow Inter-locking Block Masonry

Abstract

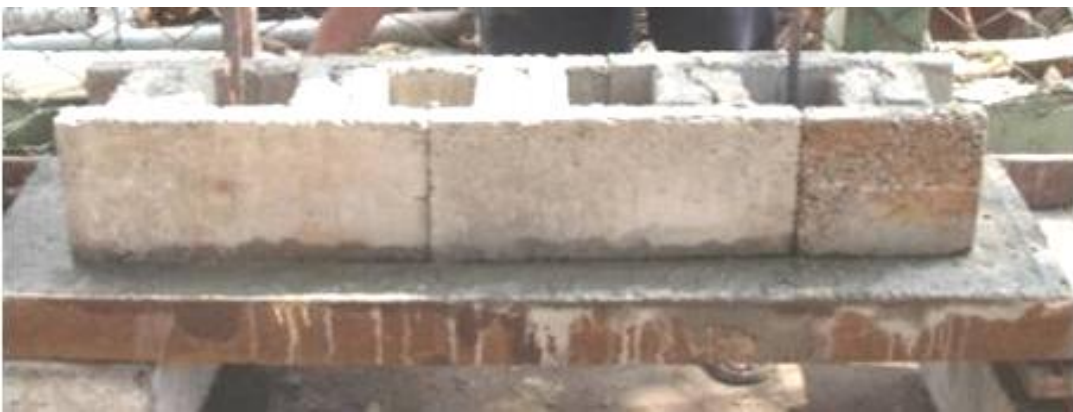
Fig. 4 Photo of wall construction showing interlocking of the blocks

Two identical walls of one metre width and 2.03 metre height were cast, with one wall having a middle horizontal band and the other without it. Both specimens had a bottom beam to anchor the vertical reinforcement and a top beam to spread the axial and lateral load over the width of the wall. The specimens are as illustrated in the Fig. 3(a) and (b) respectively. Both walls had vertical reinforcing bands spaced 600 mm centre-to-centre. The moulds used for casting the blocks were old and so the blocks had some seating problem. To facilitate proper seating, cement mortar which consisted of 2 mm sand and cement in the proportion of 1:4 was used. A single steel bar of 12 mm diameter and grade Fe 415 was used in the vertical reinforcement bands and grouted with concrete of grade M25. The lateral band on top and middle were reinforced with 4 nos. of 12mm diameter bars with 8 nos. of 6 mm diameter shear reinforcements. The walls were constructed on a steel channel for easy handling. Shear keys were provided in HIL block masonry suitably welded with channel which is fixed on to the strong floor using bolt arrangement. A photo of the first course is shown in Fig. 4 where the interlocking of the blocks can also be observed.

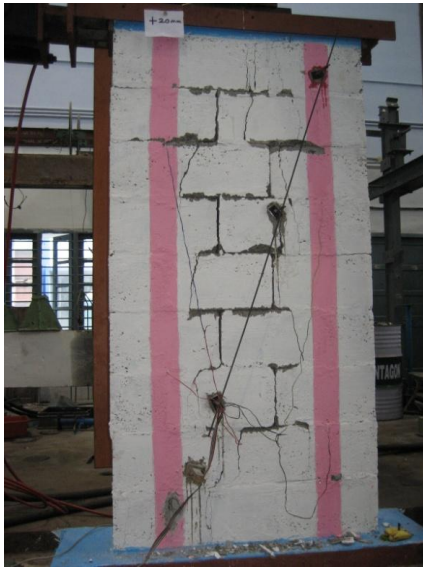
Initial response to loading in the linear range exhibited very little outward evidence of damage. The first instance of damage was the formation of vertical cracks in the top and middle section of the wall at 5 mm displacement. The length of the cracks varied from half the length of stretcher unit to full height of one masonry block. The cracks were located at the interface between the grouted vertical cell and the adjacent un-grouted masonry. The cracks are the outcome of tensile stress concentration at the discontinuity. The stresses were generated by the horizontal loads applied to the top of the HIL block masonry. A maximum load of 71.5 kN was taken by the HIL block masonry wall at a lateral displacement of 7.5 mm and this capacity was maintained until 11.5 mm. Both strength and stiffness degradation can be observed in the hysteretic behaviour. Soon after the attainment of the maximum load it was observed that significant resistance deterioration took place due to bulging of HIL block masonry units at the central part of the wall (see Fig. 7(a)), similar to the wall tested by Tomažević *et al* (2006). Eventually, the wall collapsed due to breaking of interlocks.

Fig. 7 Photo showing damage to (a) Specimen 1 and (b) Specimen 2
