SECM/15/130

RC Jacketing on RCC frame of Overhead water tank using results of Non Destructive Testing - A case study.

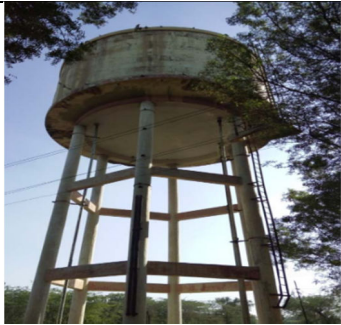
<p>Figure 1</p>
02	Outer wall of water tank above C-1, C-2	Water Seepage

Sr. No	Location	Name of Distress	Photos
01	Outer wall of water tank C-3 & C-4, Outer wall of water tank C-5 & C-6, Outer Slab near C-1,C-2,C-3,C-4,C-5	Patch of dampness

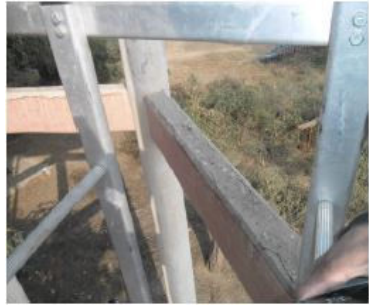
03	Vertical Cracks in bottom and middle parts of Column No. C-1. Horizontal cracks from bottom to top in Column No. C-2, C-3, C-4, C-5, C-6. Vertical cracks in bottom and middle parts of Column No. C-3, Beam No. B-2, B-4, B-5, B-6, B-7, B-8, B-9, B-10, B-11	Moderate Cracks (5mm to 10mm)

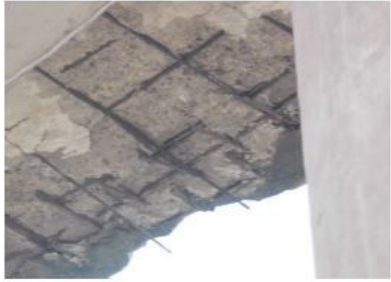
04	Bottom Part of Column C-1, Middle part of Column C-1, Bottom Part of Column C-2, Inner side of Beam B-2, Soffit of Beam B-8, B-3, B-1, Patches in outer slab	Corroded Reinforcement

- Propping the beams on all the sides of the columns for full vertical height. The props shall be able to take the total load coming on to the column.
- Chipping open the cover concrete until all the corroded steel rods are and cleaning of rods with brush

- Chipping the spelled surface of concrete to remove all loose materials. Then brushing it with steel wire brush to remove all loose particles. Washing the surface with potable water.

- Applying a coat of anticorrosive coating like NITO-ZINCPRIMER manufactured by M/s FOSROC or approved equivalent to all the existing reinforcement.
- Anchoring new bars by drilling holes in the tie beams for a length of 10 times the diameter of bar.(10XDia of bar)or into the pedestal. Additional bars thus introduced are bonded with the concrete using Hilti chemicals for re-barring. Tie new longitudinal bars using new column ties. The ties have to be anchored into the concrete by drilling holes in the concrete and inserting the ends of the ties into the holes. The depth of drilling shall be such that length of the ties from the center of
