STRENGTH ASSESSMENT OF STEEL TOWERS

Department of Civil Engineering, University of Moratuwa

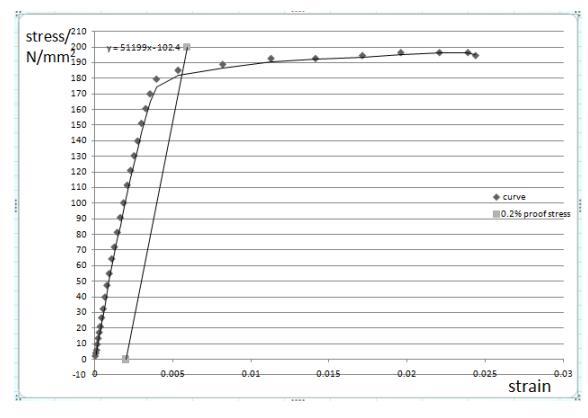
Fig 6 Stress-strain curve obtained from test

From the results (*see Fig 6*) tensile yield strength, ultimate tensile stress and Young's modulus were found as 183 N/mm², 195 N/mm² and 51.2 kN/mm², respectively. Using the obtained mechanical properties a model generated with appropriate dimensions.
