# Feasibility study of carbon black contaminated silica sand in the production of black blocks

K.Baskaran,

Senior Lecturer, Department of Civil Engineering, University of Moratuwa (Email: <u>baskaran@uom.lk</u>) K.Gopinath, Graduate Research Student, Department of Civil Engineering, University of Moratuwa (Email: <u>atk.gopinath2006@gmail.com</u>)

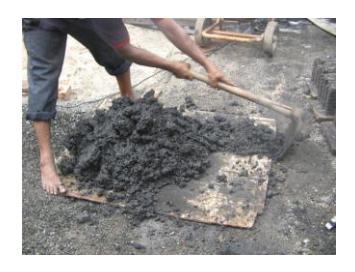
(a) Mixing the constituents

Mix proportion of 3:3:4:1 (black sand : sand : chips : cement) was selected to make the black blocks and water to cement ratio was selected as 1, both of which were based on the previous study conducted at University of Moratuwa [9] which is shown in Table 1. Before mixing the constituents, debris in the carbon black contaminated sand were removed. Then the constituents were thoroughly mixed and the mix was placed and compacted into the moulds in three layers. Each layer was compacted using a tamping rod. After preparing the black blocks, they were wetted on a regular basis for curing at least for seven days. Then, they were kept in stacks for 28 days to gain strength. Figure 1 shows the mixing, compacting and curing of black blocks.

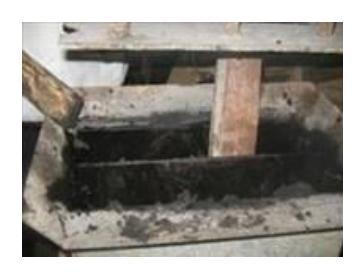
(b) Compaction by a tamping rod

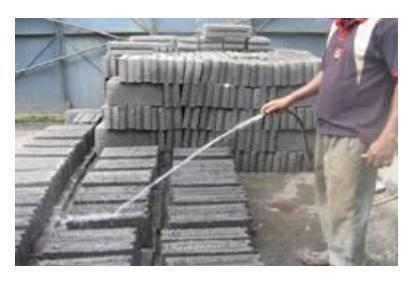
(c) Curing of black blocks Figure 1: production and curing of black blocks

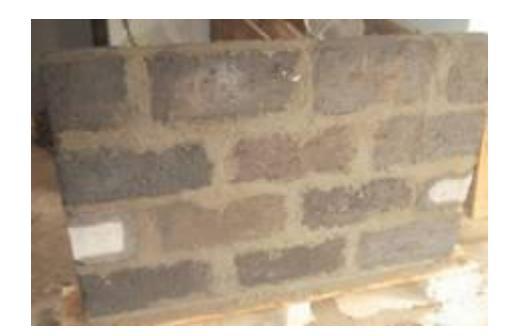
Figure 2: Sample panel used for compression testing

Before making the panels, individual blocks were immersed under water for about 5 to 6 minutes and sample panels were built within one hour of the removal of blocks from water [12]. 10 to 15 individual blocks were used to make every sample panel. These sample panels were covered with polythene sheet for a period of three days continuously and then kept uncovered until the testing being done. The panels were tested after 28 days for compression. These sample panels were built up in such a way that 4 block courses height and 2.5 blocks long as shown in Figure 2. Three sample panels (C1, C2, and C3) were made and tested in compression using the universal testing machine one by one as shown in Figure 3 and the failure loads and the corresponding compressive strengths are tabulated in Table 4. Failure pattern observed during the compression testing is shown in Figure 4.

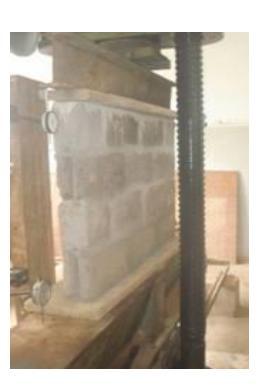
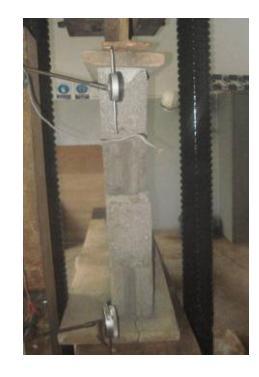
Figure 3: Application of compressive load

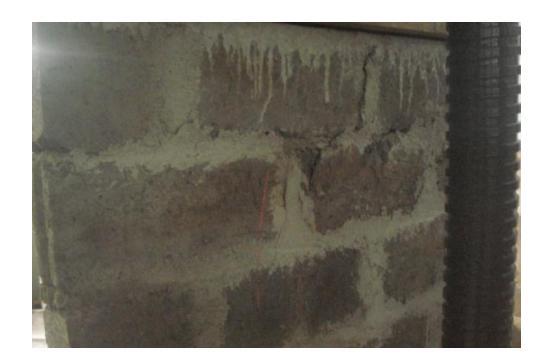
Figure 4: Failure patterns due to compressive load

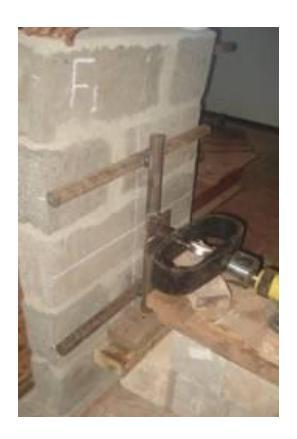
(a) Flexural testing panel arrangement 1

#### Figure 5: Flexural testing panel arrangements

The flexural strength is a predominant parameter when designing masonry units if bending is critical. Flexural strength testings were done to the sample panels in two orthogonal directions. When the failure surface is parallel to the bed joints, the sample panels were built up in such a way that panels were of 1.5 blocks long and 5 block courses high as shown in Figure 5(a). When the failure surface was perpendicular to the bed joints, sample panels were arranged in such a way that the panels were of 2.5 blocks long and 4 block courses high as shown in Figure 5(b) [12]. After 28 days from casting, panels were tested for flexural strength, by applying uniformly distributed loads. Panel no F1, F2, F3, F4, F5 and F6 were used for testing flexural testing. Sample wall panels were tested under four point loading in two orthogonal directions. Outer bearings were placed 50mm away from the edges of the sample panels and spacing of inner bearings were varied to have equal shear spans. Then the flexural stress was applied at a rate of 0 to 0.4N/(mm<sup>2</sup>/min) by using a hydraulic jack as shown in Figure 5. The failure pattern during the flexural testing is shown in Figure 6.

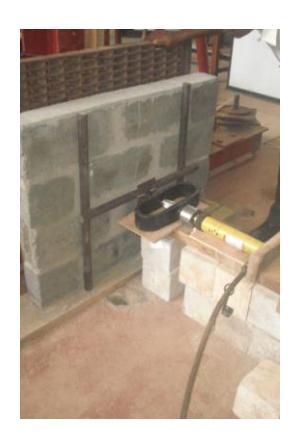
(b) Flexural testing panel arrangement 2

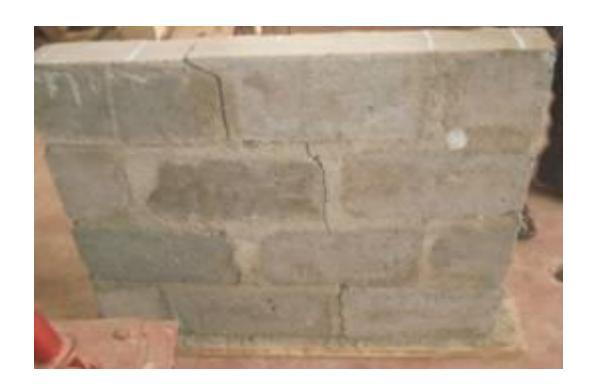
Figure 6: Failure pattern of the panel after flexural testing

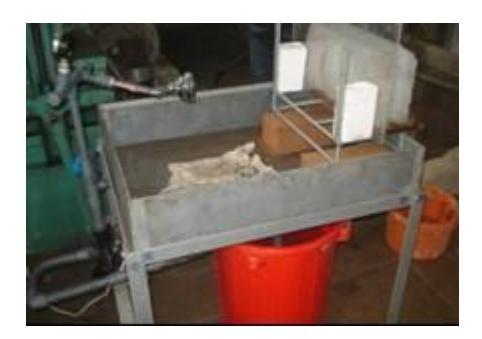
(a)Pressure drizzle apparatus

#### Figure 7: Pressure drizzle testing setup

The apparatus, shown in Figure 7 was used for this test, includes a stand-mounted 50mm spray nozzle, water pump, pipes and valves, pressure gauge, water tank, filtration screen to remove

particulate matter, mounting for specimen, shield and gasket. This test has been selected to simulate the heavy rain conditions expected in tropical weather conditions. The standard erosion test apparatus has been modified to suit the Sri Lankan condition and fabricated at the Department of Civil Engineering, University of Moratuwa. Figure 7(a) shows the apparatus assembled. This apparatus can spray a water jet at the pressure of 50kPa through a nozzle of 40mm diameter circle. After 60 minutes, depth of each pit due to water spray was measured to the nearest millimetre, by inserting flat-ended rod. The maximum depth is taken as the rate of erosion, D (mm/hrs) for the specimen. The durability is measured in terms of erosion rate (mm/hrs) evaluated on the basis of pitting depth or time taken to completely penetrate the eroded specimens.

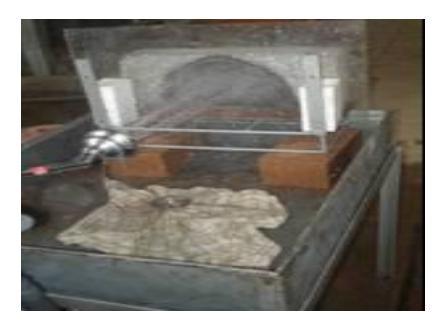
(b) Jet of water spray was applied to the black block sample

The accelerated erosion test could be used to determine relative erosion resistance of blocks. Three specimens were subjected to continuous jet of water spray for 60 minutes or until water has completely penetrated the specimens. Performance, in terms of erosion rate (mm/hrs), could be determined on the basis of pitting depth or time taken to completely penetrate the specimens.

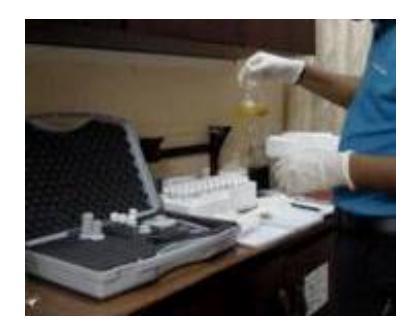
Figure 8: Water quality testing setup

During the rainy seasons, particularly in lower lands, black block wall panels are likely to be submerged under flood. Whereas it is important to study whether these black blocks immersed under water for certain days, contaminate the water body. Thus a series of tests were conducted for the water quality parameters such as pH, chloride (Cl<sup>-</sup>) (mg/l), fluoride ( $\overline{F}$ ) (mg/l), total alkalinity and total hardness as CaCO<sub>3</sub> (mg/l), sulphate (SO<sub>4</sub><sup>-2-</sup>) (mg/l). Figure 8 shows the test setup being used to conduct these series of water quality tests. The level of concentrations of the above water quality parameters were measured under laboratory conditions after immersing the black blocks under water for three days and compared against the Sri Lankan Drinking Water Standard SLS 614-1983 [14]. The observations on water quality parameters against the Sri Lankan Standard are tabulated in Table 8.
