Deriving Damage Indices for Concrete Girder Bridges subjected to Flood Loading

F.Kalendher^{1*}, S.Setunge¹, H.Mohseni¹ and W.Lokuge²

¹ RMIT University, Australia
² University of South Queensland, Australia
*Email-farook.kalendher@rmit.edu.au

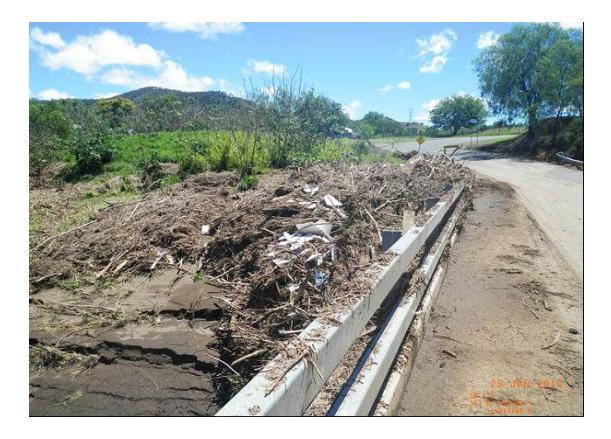
Figure 1: Damaged Bridges in Lockyer Valley Region in Queensland

Bridge could damage in many ways when it is under an extreme flood event. Farook, Lokuge [4]. If the bridge is completely inundated during the flood, the damage to the bridge depends on the length of time it was submerged as well as the types of debris collected around or passing the bridge components. Extra care should be taken to inspect the supports of the bridges, even after the flood water recedes. Approaches of a bridge could be damaged due to debris impact, settlement or depressions. Debris against substructure and superstructure, bank erosion and damage to scour protection will damage the waterways. Bridge substructure could fail due to movement of abutments, wing walls, piers, rotation of piers and missing, damaged dislodged or poorly seating of the bearings while the superstructure could fail due to the debris on deck, rotation of deck, dipping of deck over piers or damage of girders. Pritchard [5] identified that urban debris such as cars; containers etc. and the insufficient bridge span to through that debris were the main cause for damaging bridges aftermath of 2011/2012 extreme flood events in Queensland. Figure 1 depicts some the damaged bridges from Lockyer Valley Region in Queensland.

Analysis on the performance of bridges under 2011/2013 flood in Lockyer Valley Region, Queensland Farook, Lokuge [4] indicates that the bridge deck is the most commonly affected component followed by the bridge approach, pier/abutment scouring, cracks in the abutment wing walls and misalignment of abutment

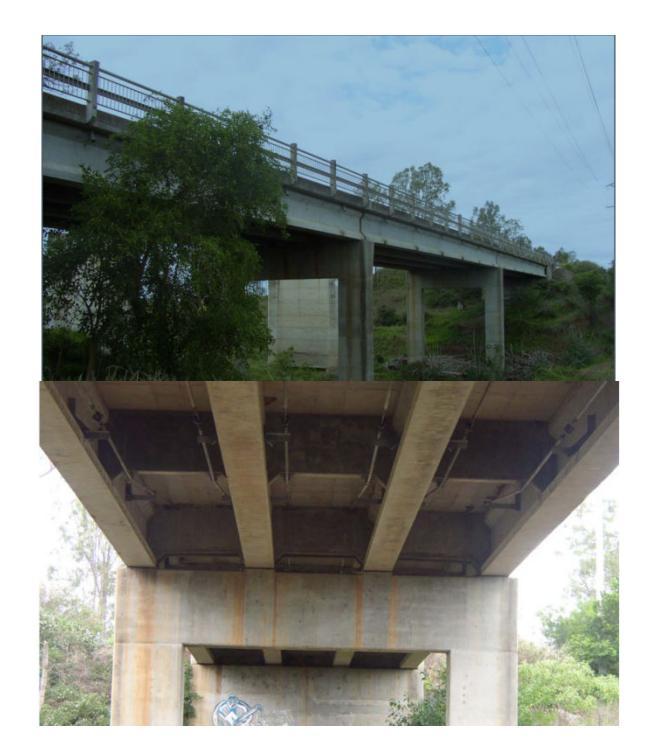
Figure 2: Tent hill Creek Bridge Configuration

For the purpose of modelling the bridge, a bridge that carries a state route of Ipswich-Toowoomba road over Tenthill Creek in Gatton, Queensland, Australia has been selected. This is a simple span reinforced concrete, prestressed I-girder bridge built in 1970's. The bridge is 82.15m long and about 8.6m wide and is supported by a total of 12 pre-stressed 27.38m long beams over three spans of 27.38m. The beams are supported by two abutments and two headstocks.

General purpose finite element software, ANSYS has been used to model the bridge deck and to analyse the flood loading effect on to it. The middle span of bridge deck was analysed. All four girders were assumed simply supported and rest on the headstock of the piers. Self-weight of the bridge and the flood loads acting laterally to one of the end girder were considered in the analysis. The flood load was fed as a pressure on the face of the end girder. The bridge deck (I-girder) has been analysed using ANSYS. Figure 2 illustrates the Tenthill Creek bridge configuration. Section details of the bridge deck and the girder is given in Figure 3.

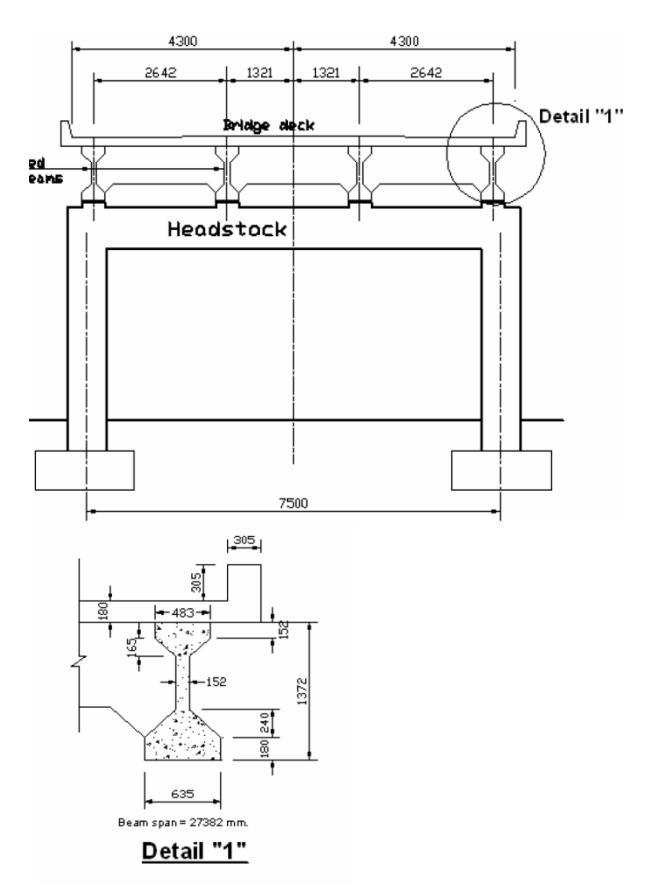
Figure 3: section details of a longitudinal prestressed I-girder beam. Nezamian and Setunge [8]

A typical beam section of the headstock is shown in Figure 3. The positive and negative flexural and shear capacities of the section were calculated in accordance with Australian standards (AS3600, 1988). The nominal steel rebars areas; nominal steel yield strength of 400 MPa for longitudinal reinforcement and 240 MPa for shear reinforcement and nominal concrete compressive strength of 20 MPa were used in the section capacity analysis. The degradation due to corrosion of the steel and creep and shrinkage of the concrete were ignored. Using an excel sheet, the existing moment capacity of the concrete girder section was found to be 600kNm.

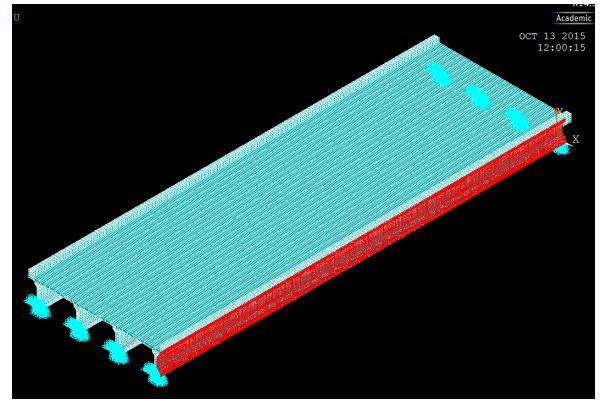
Figure 4: ANSYS bridge Deck Model

ANSYS model was run for different flood velocities ranging from 0.5m/s to 5.0m/s in steps of 0.50m/s increment. Figure 4 depicts the bridge deck model used in the analysis.

Horizontal support reaction of the end girder was obtained each time from the ANSYS Postprocessor. Using these reaction values flood induced bending moment of the end girder was calculated with the help of an excel sheet as shown in table 3

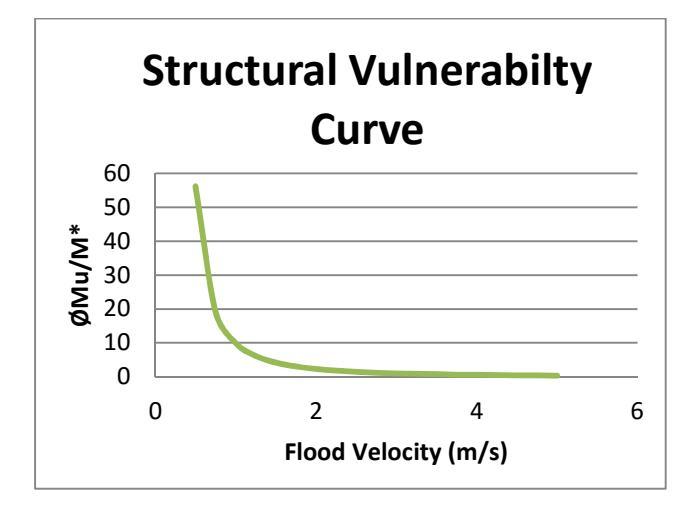
Figure 5: Structural vulnerability Curve for Tent hill Creek Concrete Girder Bridge

moment (W)							
Velocity (m/s)	Pressure (kNm ⁻²)	Reaction (kN)	W(kN/m)	M*	ØMu/M*		
0.50	0.275	1.276	0.0932	8.544	56.18		
1.0	1.1	7.223	0.527	48.355	9.93		
1.5	2.475	17.133	1.252	114.71	4.18		
2.0	4.4	31.001	2.265	207.61	2.31		
2.5	6.875	48.848	3.568	327.04	1.47		
3.0	9.9	70.652	5.161	473.02	1.01		
3.5	13.474	96.42	7.043	645.53	0.74		
4.0	17.6	126.15	9.215	844.57	0.57		
4.5	22.275	159.85	11.676	1070.2	0.45		
5.0	27.5	197.8	14.448	1324.3	0.36

Structural Vulnerability curve for this girder bridge is drawn as shown in figure 5.
